COALTECH

Test Report

Vibrant Roadheader Trial

Brandspruit Colliery

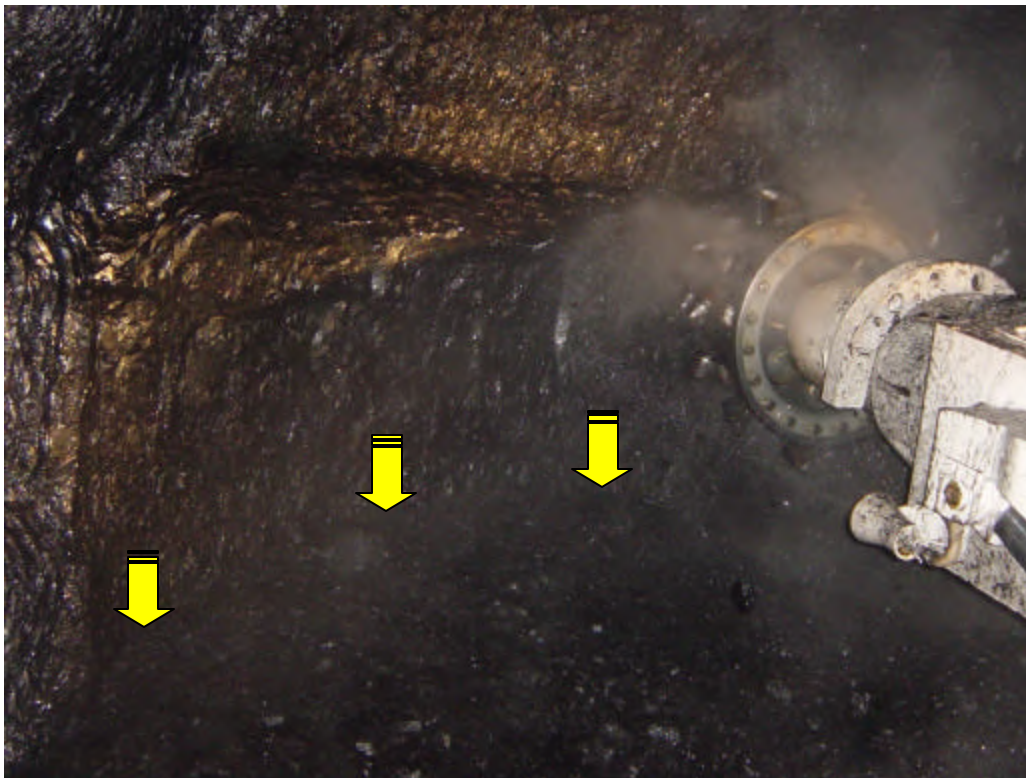
Figure 5: Muck pile forming below cutting head(below arrows)

The loading spade is too far behind the cutting head, resulting in a cut coal muck pile forming below the cut face (Figure 5), up to 1.4 m high. When cutting the lower half of the face, this cut coal is then reground to a fine mix. The muck pile also buries the cutting head when making the lower passes, which hinders the operator from accurately controlling floor cutting height, resulting in a slightly uneven floor and occasional ridges that foul with the loading spade under the muck pile when the machine advances for the next cut. Sometimes the operator continued to cut coal while the shuttle car was away, unloading. Normal advance times then often slowed down while moving forward due to the sheer volume of the muck pile created.

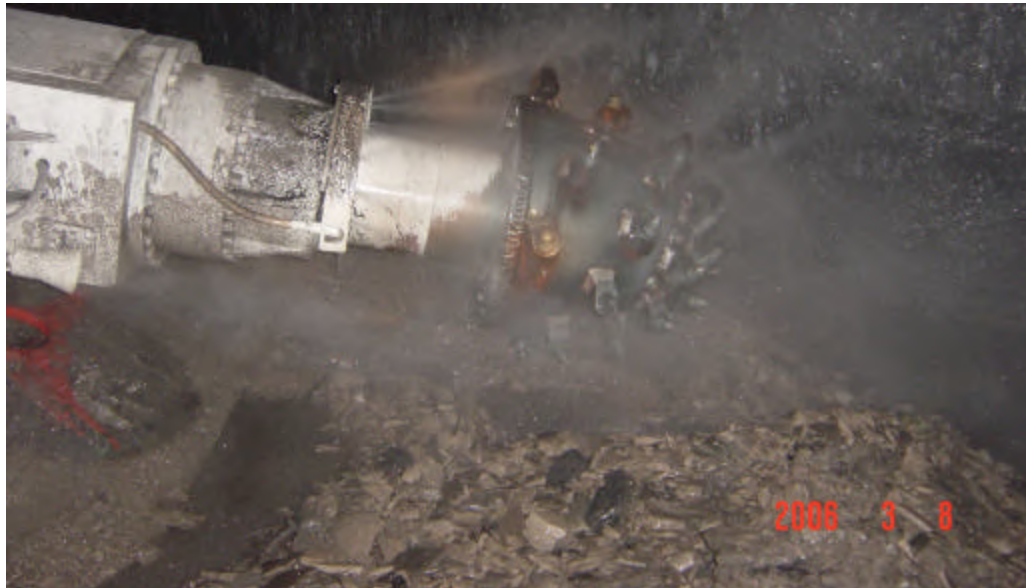
Figure 6: Cutting a sump into the sandstone floor

A 4.5 m³ sump (Figure 6) was cut in two hours into the sandstone floor on the 8th of March 2006, measuring 6.1 m long, 3 m wide and 500 mm deep at the deepest part of the 'wedge'. The machine was fairly stable throughout the process and conducted the task with relative ease. After cutting the sump, no picks needed replacement due to tip-wear (though some were replaced due to failure of the retaining circlips). Generally, the same picks were used throughout the initial coal and stone cutting tests.

During the cutting of the sump, the loading system proved unable to remove any significant amounts of cut stone from the cut sump and extreme regrinding of the cut rock occurred. Together with the dust suppression water, this resulted in a fine paste forming in the cut cavity 'mud-bath', eventually fully engulfing the cutting head.

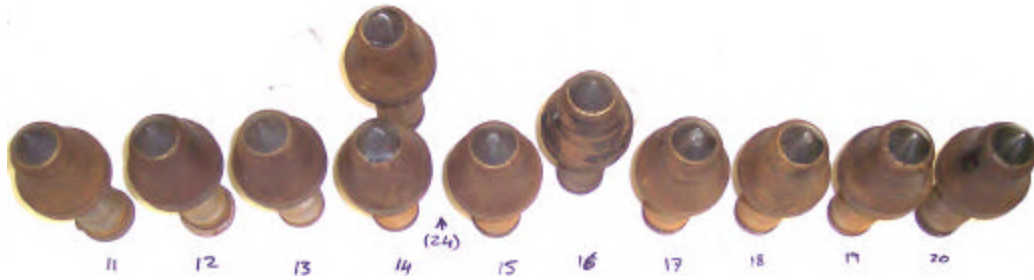
Figure 7: Full spiral of picks removed after cutting sump

After completing the sump cutting test, the picks were inspected (Figure 7). Though the pick tips generally did not show any signs of significant wear, except for two pick tips that had fractured (Figure 7, pick 14 and 24, 'coincidentally' located in the same position in their respective spirals), most pick shanks were found to be very loose in their respective pick boxes. Subsequent measurements proved that significant wear on the pick box had occurred (Table 2B, Appendix 2).

The regrinding of the cut stone in the floor is so severe that the fine paste formed acts as an extreme 'grinding paste' between the pick shank and the un-sleeved pick holder, resulting in excessively high wear rates to these interfacing parts. As a direct result of this severe pick holder wear and the anticipation that six air crossings into the floor had to be cut, plans were immediately put into place to order a new cutting head from Aerosun, fitted with our 'own' pick boxed which incorporated a removable hardened sleeve. However, the next set of tests proved challenging and the sump cutting test was not extensively repeated. Since subsequent cutting tests in stone were all conducted in the face or roof, the regrinding problem did not reoccur and further pick shank wear was not significant.

Any future equipment should be fitted with pick box sleeves to maximise the economic life of the boxes.

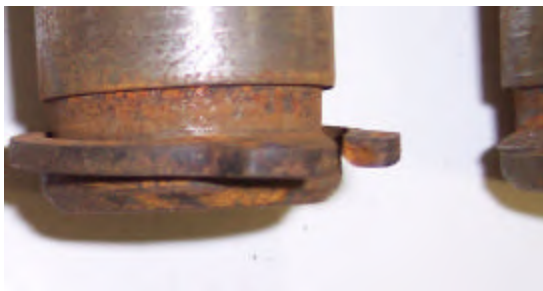
Figure 9: Loos fitting circlip (left) and groove wear (right)

From Table 2C, it is clear that all pick boxes had experienced severe wear on their bores (except for one measurement, all measured diameters are larger than the 'new' diameter condition). It is also very clear that the manufacturing tolerance on the Aerosun picks ('A' in Table 2C) varies very much. The Kennametal picks ('K' in Table 2C) seems to be made closer to an average shaft diameter of 29.8 mm, and thus also shows up yellow in the table (i.e. above the size tolerance for the Aerosun picks). Also noteworthy is that the Kennametal picks in the second spiral ('S2' in Table 2C) worked a slightly shorter period than the Aerosun picks in the third spiral ('S3' in Table 2C), yet qualitatively are worse off for wear than the Aerosun picks.

Measurements also indicated that shank wear directly behind the pick head was slightly less than the shaft wear at the other end of the pick (closest to its circlip). This wear (and that to the pick boxes) is thought to predominantly originate from the grinding past formed during the floor cutting test (Section 2.1.3, above).
