**COALTECH 2020**

## **Task 1.4**

# **Geotechnical factors affecting high- and low-wall stability in opencast coal mines**

**May 2004**

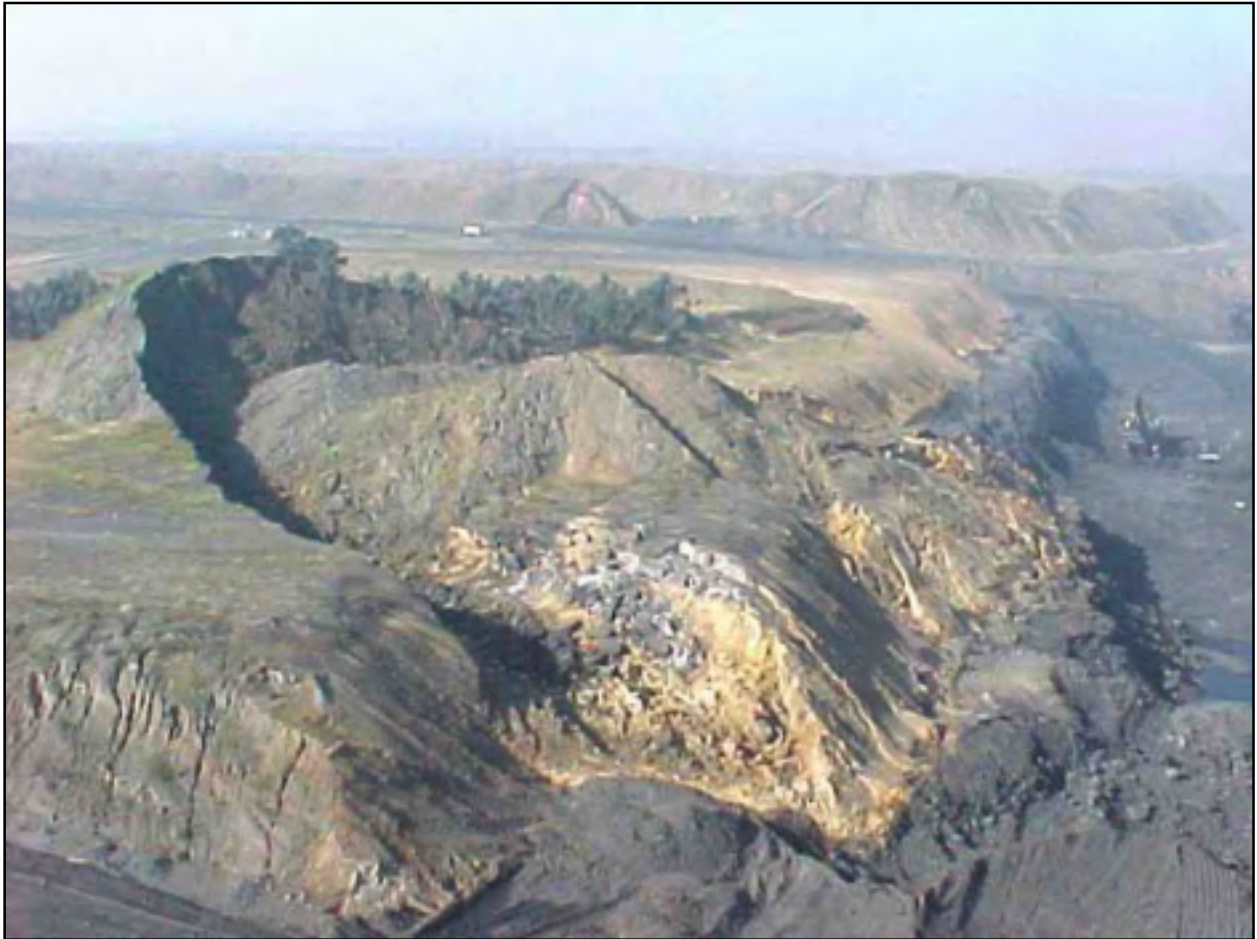
During 2002, several high- and low-wall collapses occurred at New Vaal Colliery, an Anglo Coal opencast mine situated in the northern Free State on the southern banks of the Vaal River, south of Vereeniging (Figure 1.1).

**Figure 1.2:** Highwall failure at New Vaal Colliery (photograph courtesy of New Vaal Colliery)

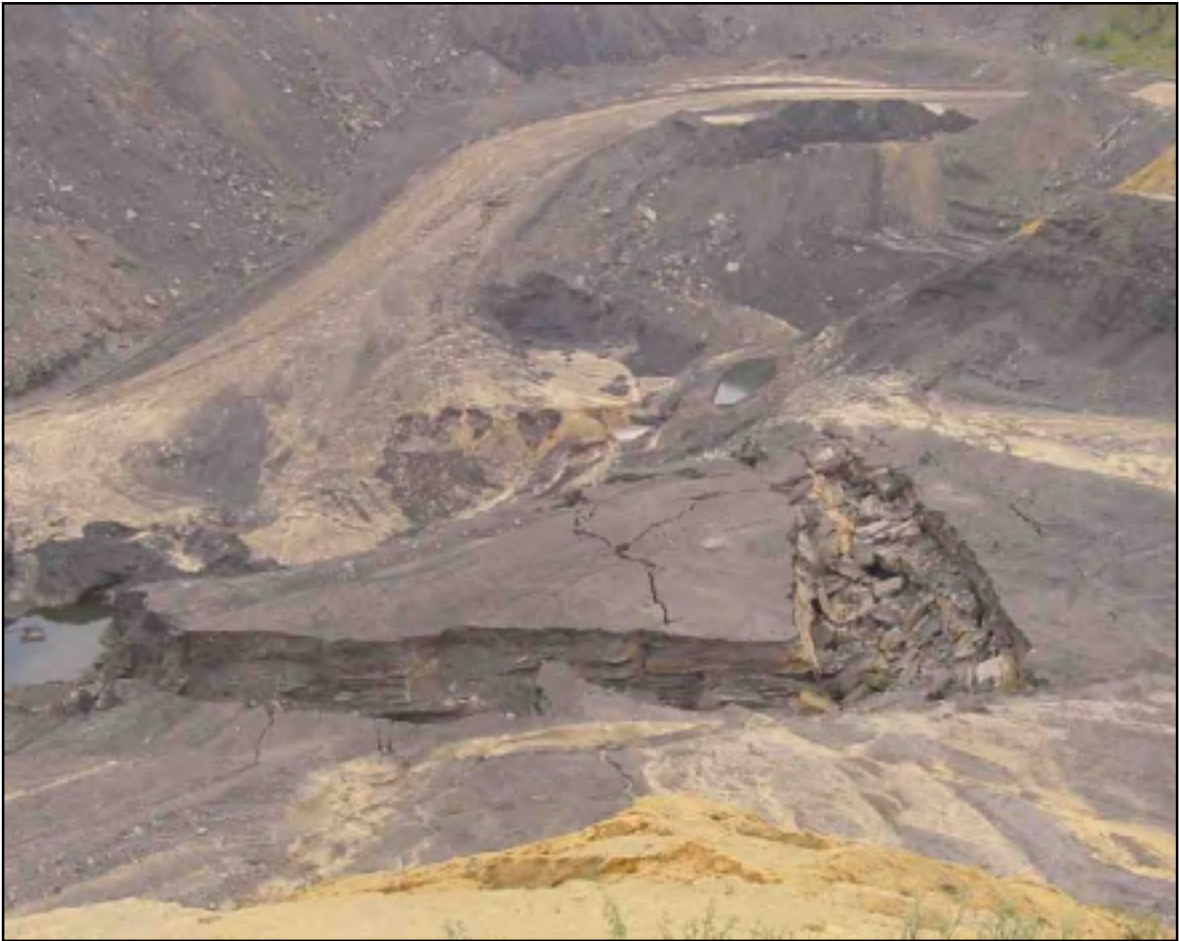
In-pit geological and geotechnical mapping, conducted during this investigation, identified two predominant failure mechanisms, namely wedge failure and planar failure (Stewart and Letlotla, 2003). Wedge failure appears to occur more commonly in the Bottom and Middle Seam coal horizons, and overlying interburden, whilst planar failure appears more common in the Top Seam coal horizon and overlying hard overburden. A possible explanation for this observation is that the geotechnical conditions that need to be met for wedge failure are more often present in the lower stratigraphic units than in the upper units. The same is true for planar failure, in that the geotechnical conditions that result in this mode of failure are largely present in the uppermost stratigraphic units. This, however, does not mean that wedge failure cannot occur in the upper zone, as evidenced by the wedge failure that occurred in the hard overburden (Figure 3.1.6).

**Figure 3.1.6:** Wedge failure in hard overburden (photograph courtesy of New Vaal Colliery)

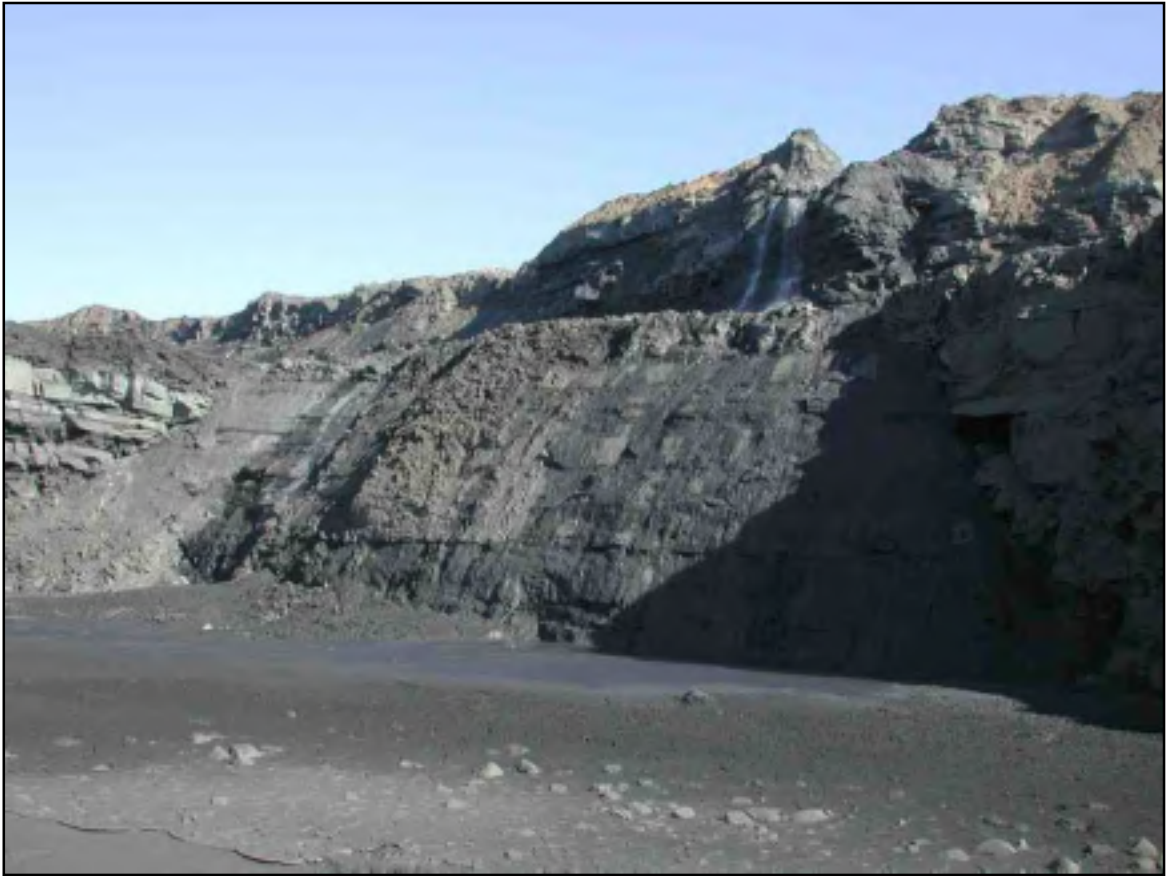
Several post-failure highwall sites were visited in the Wonderwater pit, and the modes of failure were determined to be either planar or wedge. Figure 3.2.3 is a photograph of a failed highwall where the mode of failure was planar, and Figure 3.2.4 is a photographed example of wedge failure. Incident reports generated by the mine geologist regarding previous highwall collapses were also reviewed. In all these cases, the contributing factors to instability were the interactions between the highwall face and geological discontinuities. No physical measurements were taken on the failure surfaces due to strict mine regulations preventing personnel from approaching the highwall. However, Figure 3.2.3 clearly shows that the failure plane is striking nearly parallel to the highwall. Rock mass property investigations carried out by mine personnel indicate that the rock strengths are generally greater than the shear stress magnitudes and, therefore, failure should not typically occur through intact rock but rather on existing planes of weakness where their attitudes (orientation and dip) relative to the highwall allow movement to occur.

**Figure 3.2.3:** A failed highwall where the mode of failure was planar (photograph courtesy of Wonderwater Strip Mine)

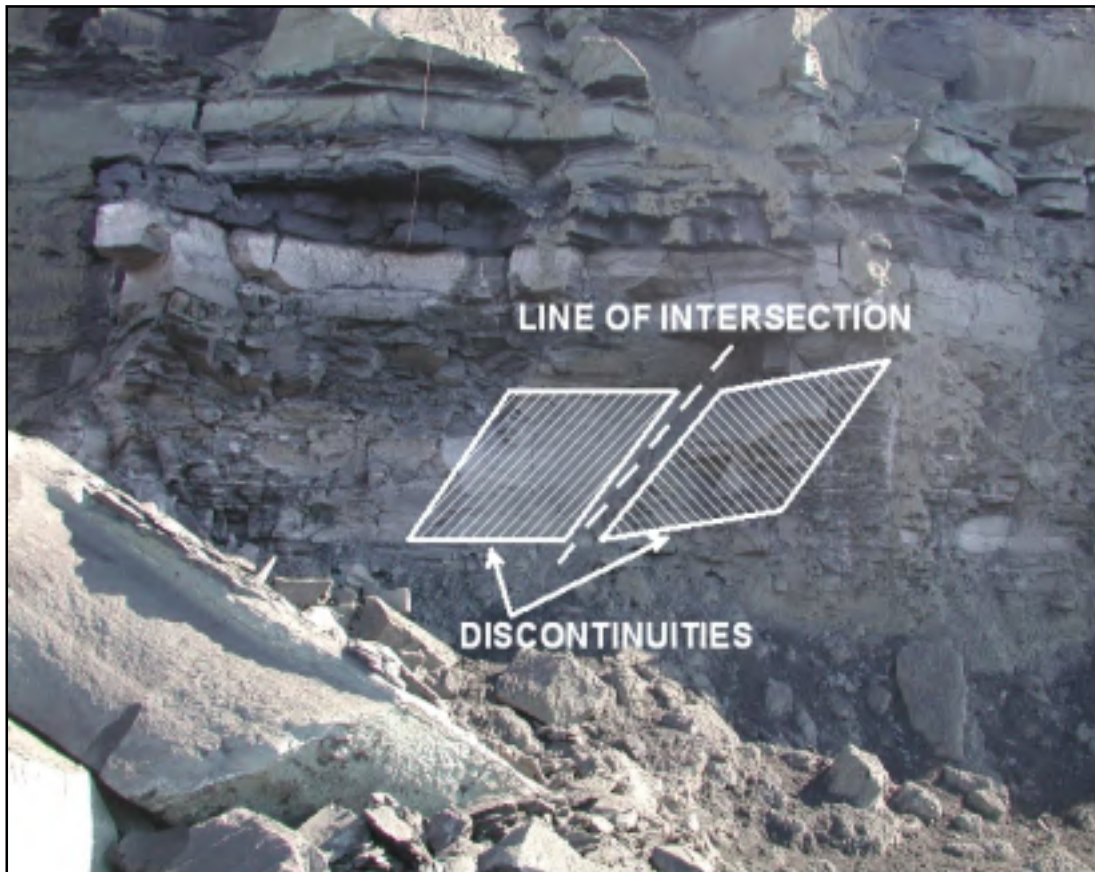
**Figure 3.2.4:** Interburden wedge failure (photograph courtesy of Wonderwater Strip Mine)

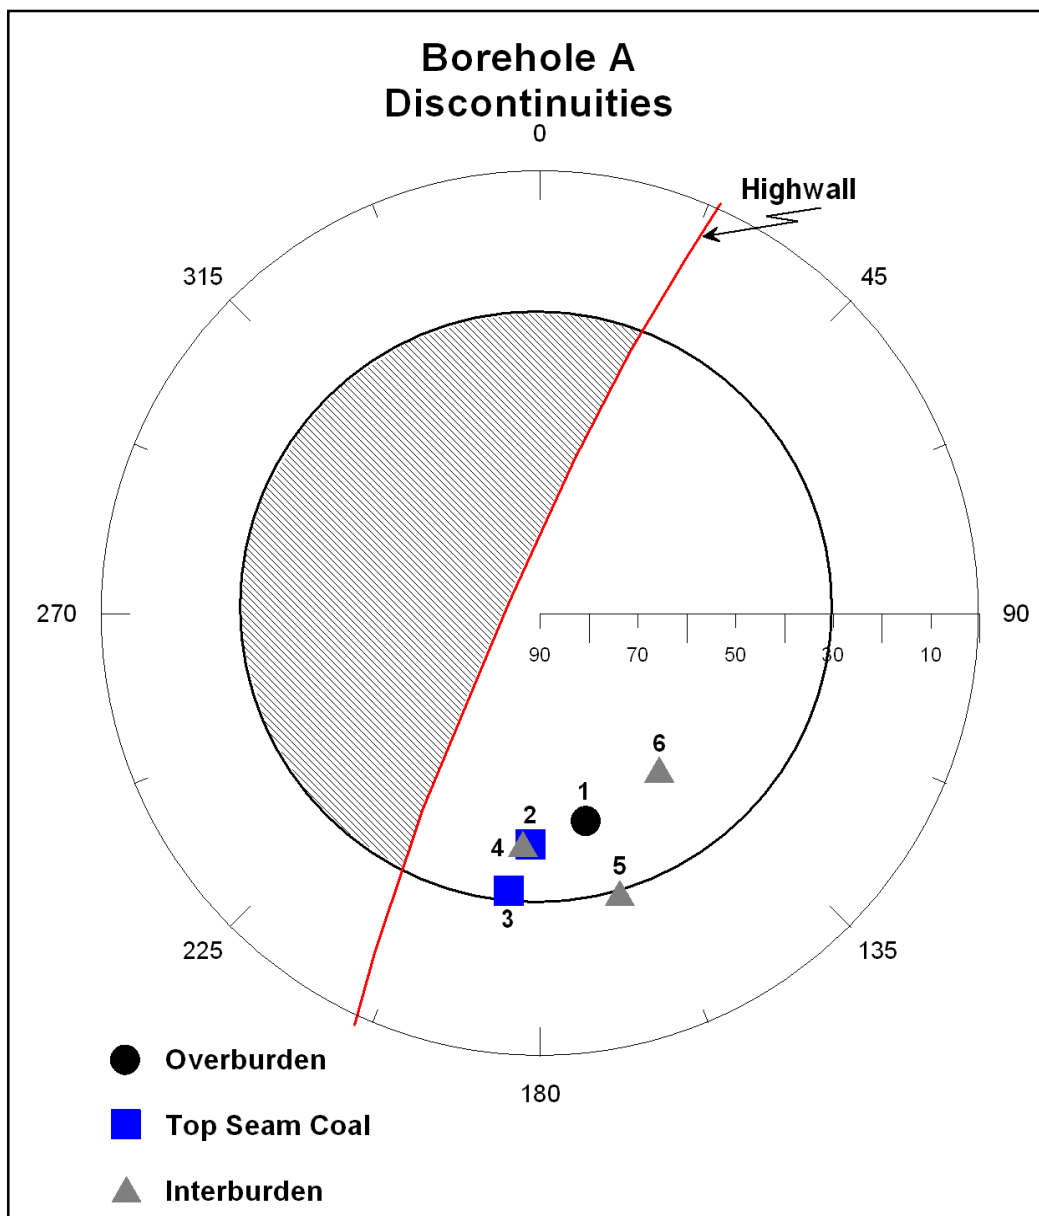
The stereoplot for discontinuities identified in the upper lithological units in Borehole A is given in Figure 4.3.1.2. As can be seen from this plot, all identified discontinuities dip in a SSE direction at angles of greater than  $30^\circ$ . Although steeper than the friction angle, the strike angle of intersection with the highwall is far greater than  $20^\circ$  and no movement is expected on these discontinuities. In addition, these discontinuities are dipping towards the upslope direction of the strata and possibly represent localised tensional fracturing of the strata.

**Figure 4.3.1.2:** Stereoplot of discontinuities identified in Borehole A for overburden, Top Seam Coal and interburden

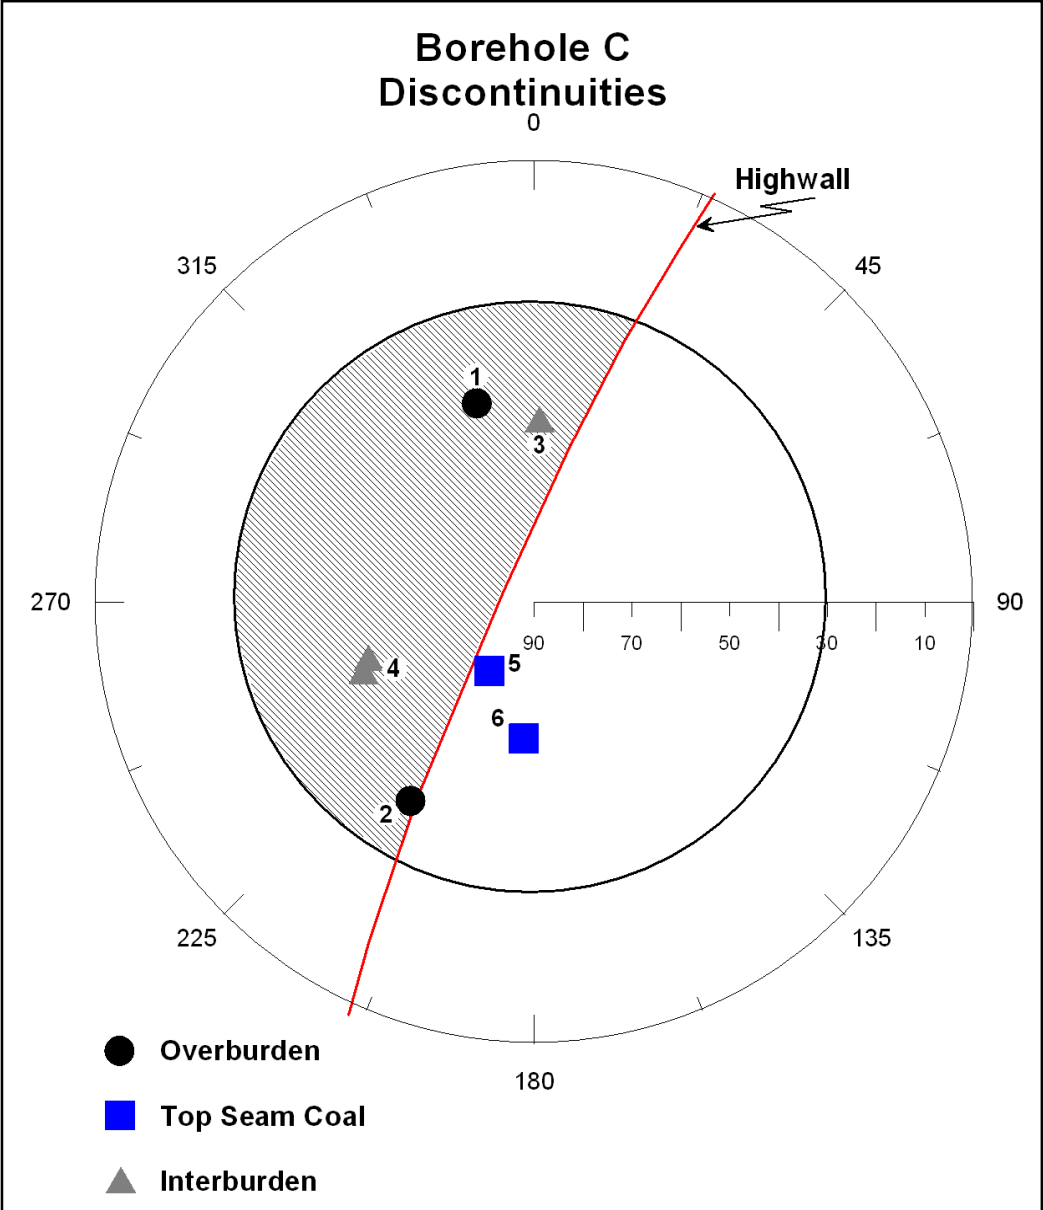
The stereoplot for discontinuities identified in the upper lithological units in Borehole C is given in Figure 4.3.1.4. Noticeably more discontinuities for the same lithological units have been identified in this borehole than in Borehole A. The borehole is positioned in an area where the strata are dipping more steeply than the strata in the vicinity of Borehole A. As previously mentioned, a relative increase in the strata dip has been observed to have an impact on the localised discontinuity frequency throughout the strata.

**Figure 4.3.1.4:** Stereoplot of discontinuities identified in Borehole C for overburden, Top Seam Coal and interburden

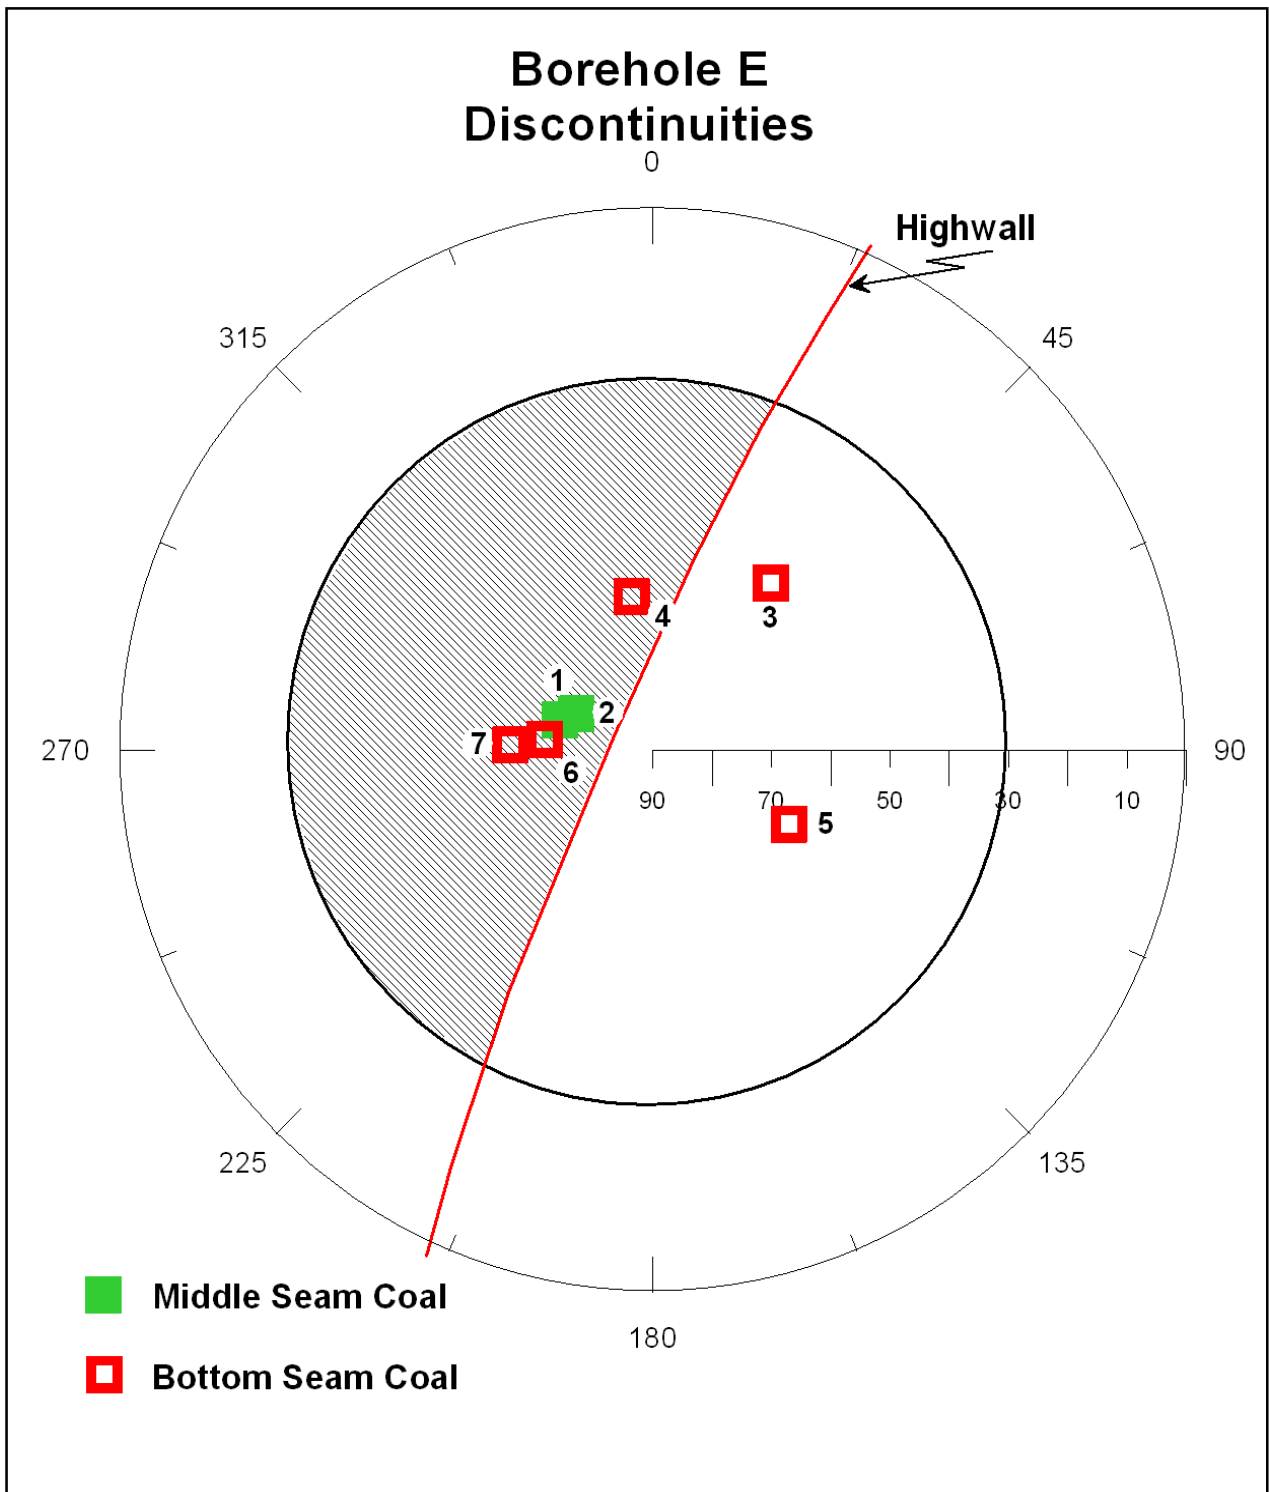
The discontinuities D1, D2, D6 and D7 all dip sub-parallel and steeply out of the highwall, indicating that plane failures are a distinct possibility. The great circles for these discontinuities are plotted on the stereoplot in Figure 4.3.2.5 and the directions of potential sliding for each discontinuity are also shown.

**Figure 4.3.2.4:** Stereoplot of discontinuities identified in Borehole E for Middle and Bottom Seam Coal units
