**COALTECH 2020**

## **Task 1.4**

# **Geotechnical factors affecting high- and low-wall stability in opencast coal mines**

**May 2004**

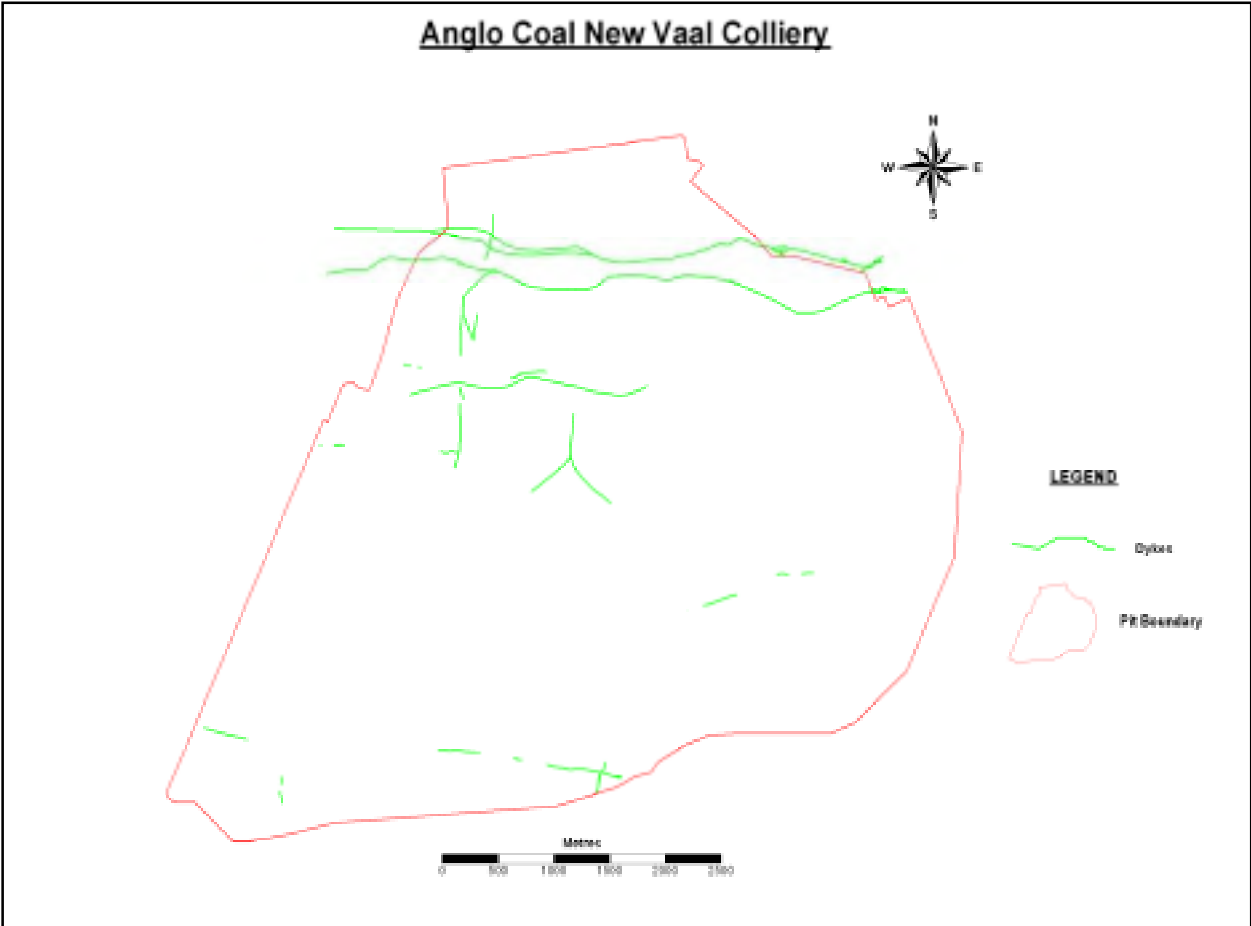
The prominent strike of these intrusions is W-E (Figure 3.1.2). This observation may indicate that the maximum principal horizontal stress is also W-E, resulting in W-E trending extensional fractures developing (Figure 3.1.3) that are susceptible to igneous intrusions in the form of dolerite dykes. The observed regional faulting pattern also displays predominant W-E strike trend (Figure 3.1.4). An in-pit joint survey (Sonneveldt and Enserink, 1997) identified two major joint sets, striking predominantly NE-SW and NW-SE (Figure 3.1.5). If the maximum principal horizontal stress is W-E, then these joints sets are considered to be conjugates resulting from this maximum principal horizontal stress.

**Figure 3.1.2:** Known dyke distribution at New Vaal Colliery (notice dominant W-E strike)

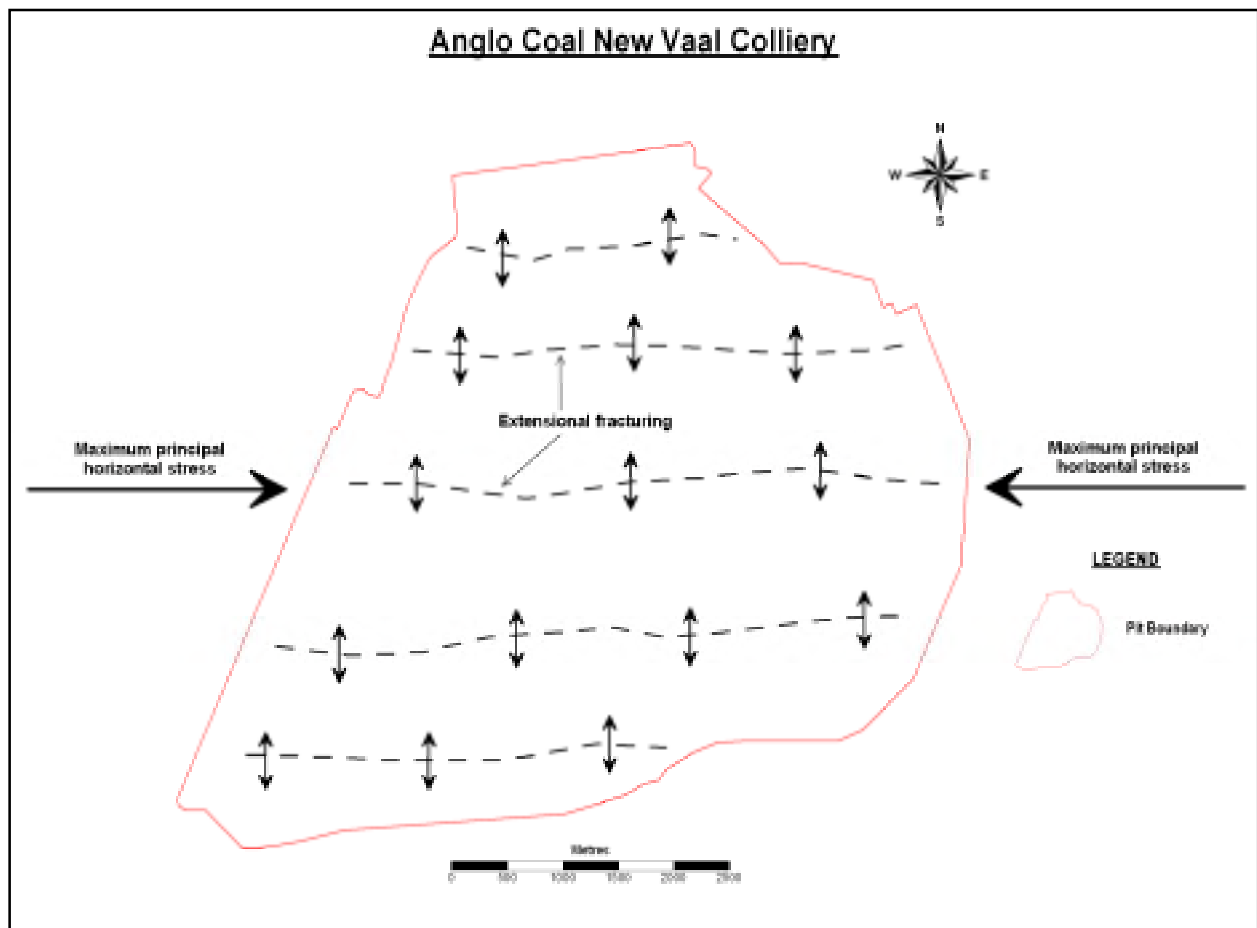
**Figure 3.1.3:** Extensional fracturing resulting from W-E principal horizontal stress

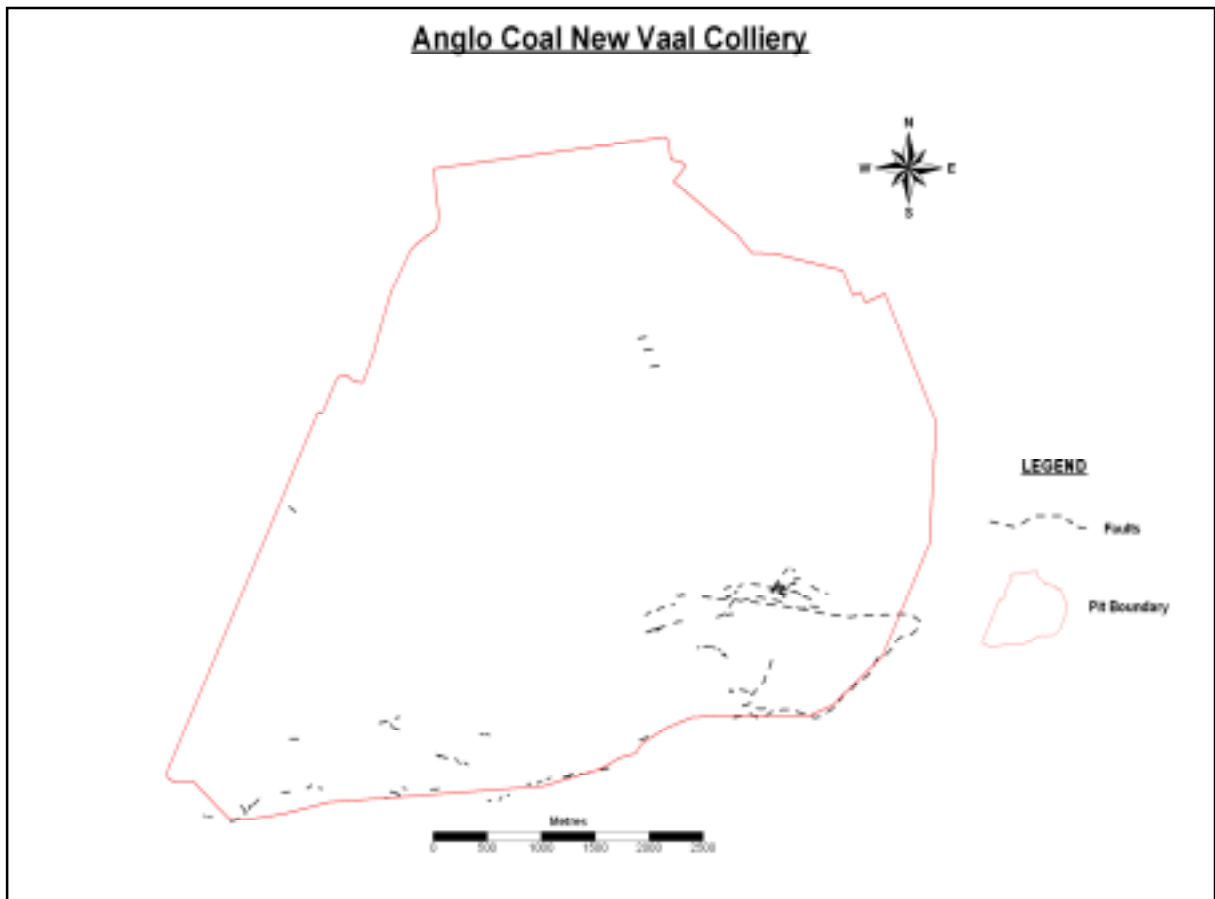
**Figure 3.1.4:** Known fault distribution at New Vaal Colliery (notice dominant W-E strike)

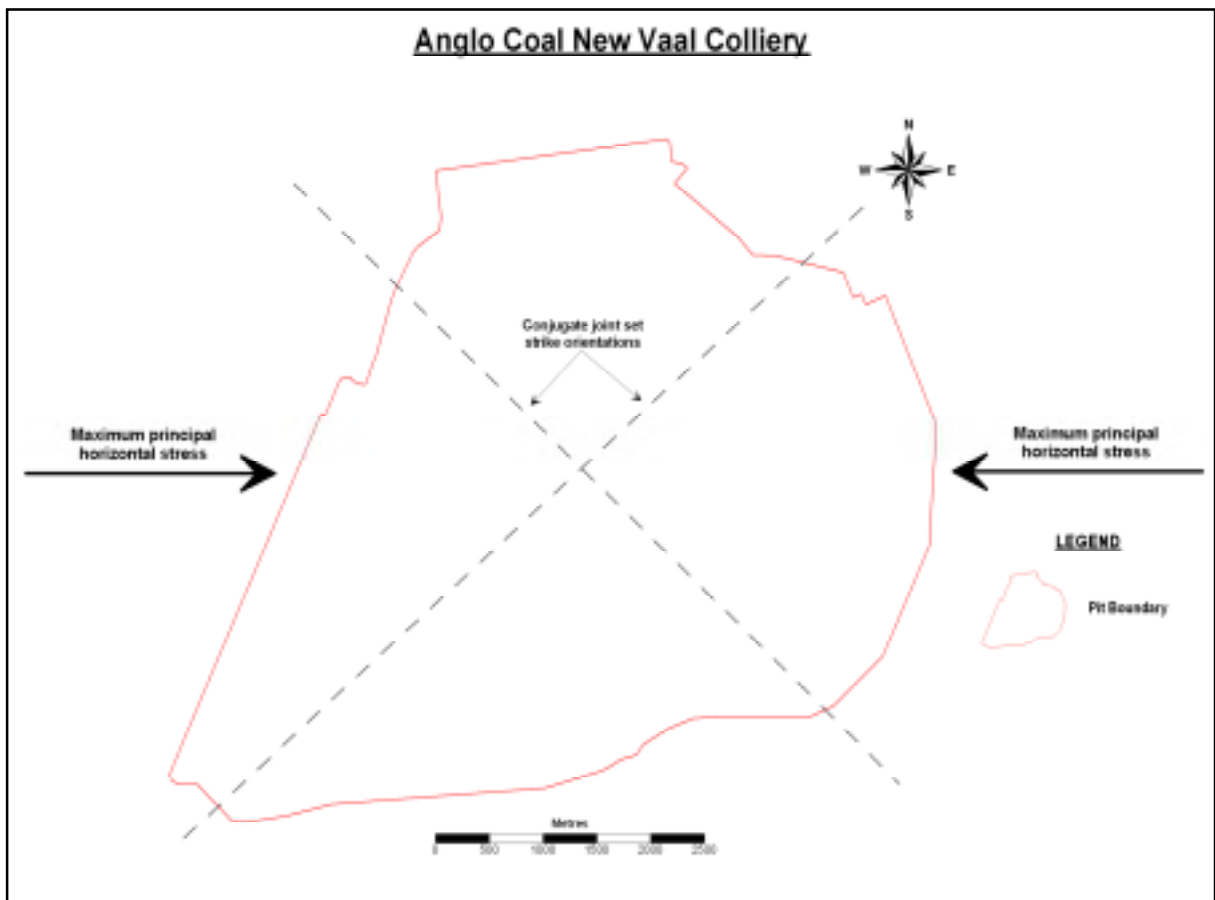
**Figure 3.1.5:** Dominant joint set orientations

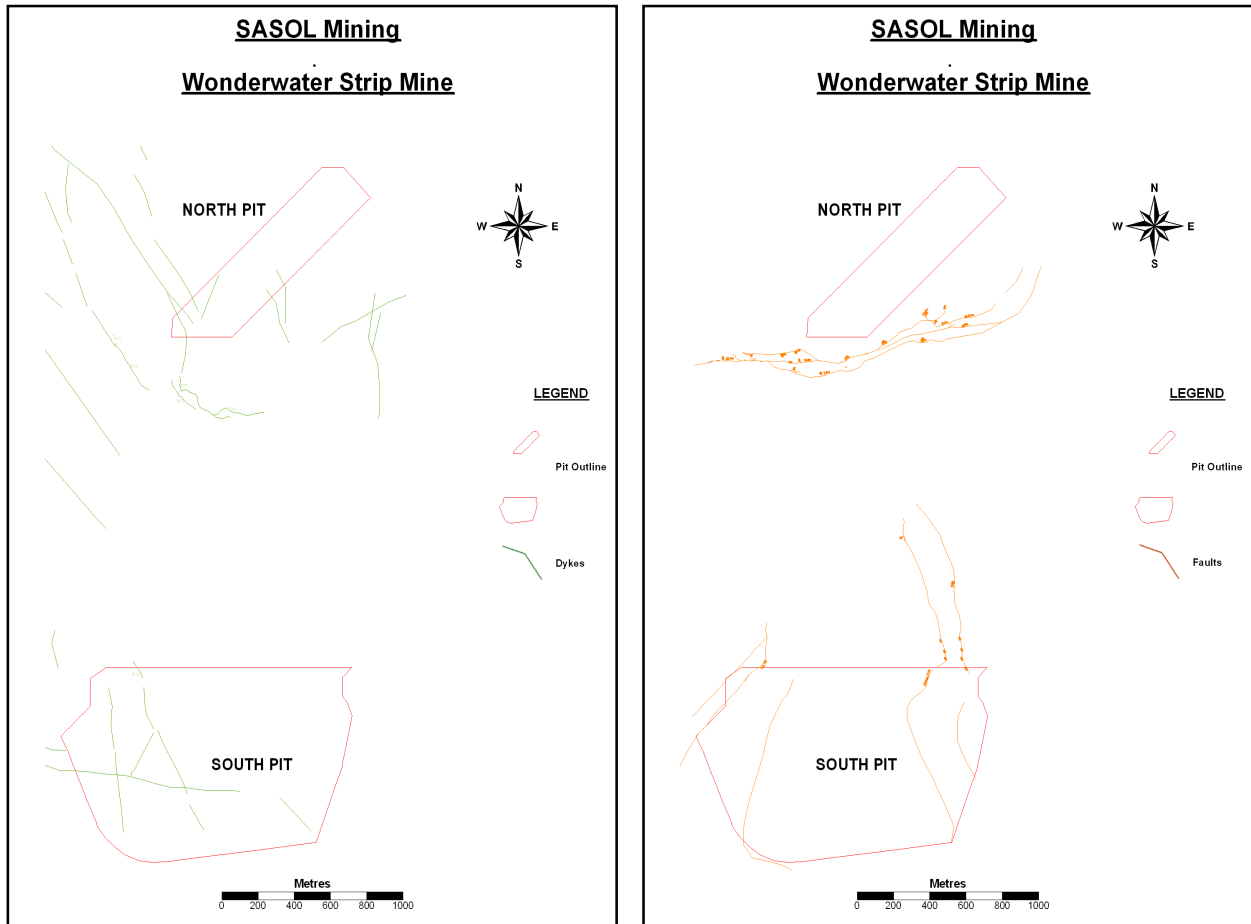
Regional geological structures include dolerite dykes and normal faults. The predominant strike of the dykes is roughly NW-SE (Figure 3.2.2.a), while the fault orientations display an equal distribution between NNW-SSE and WSW-ENE strike trends (Figure 3.2.2.b). The roughly W-E striking faults on the southern boundary of the North Pit are associated with the major pre-Karoo fault in this area and are not considered to be associated with the maximum principal horizontal stress. Considering the orientations, therefore, of the dykes and southern faults, the maximum principal horizontal stress direction is likely to be NW-SE.

**Figure 3.2.2:** a) Wonderwater dyke distribution; b) Wonderwater fault distribution

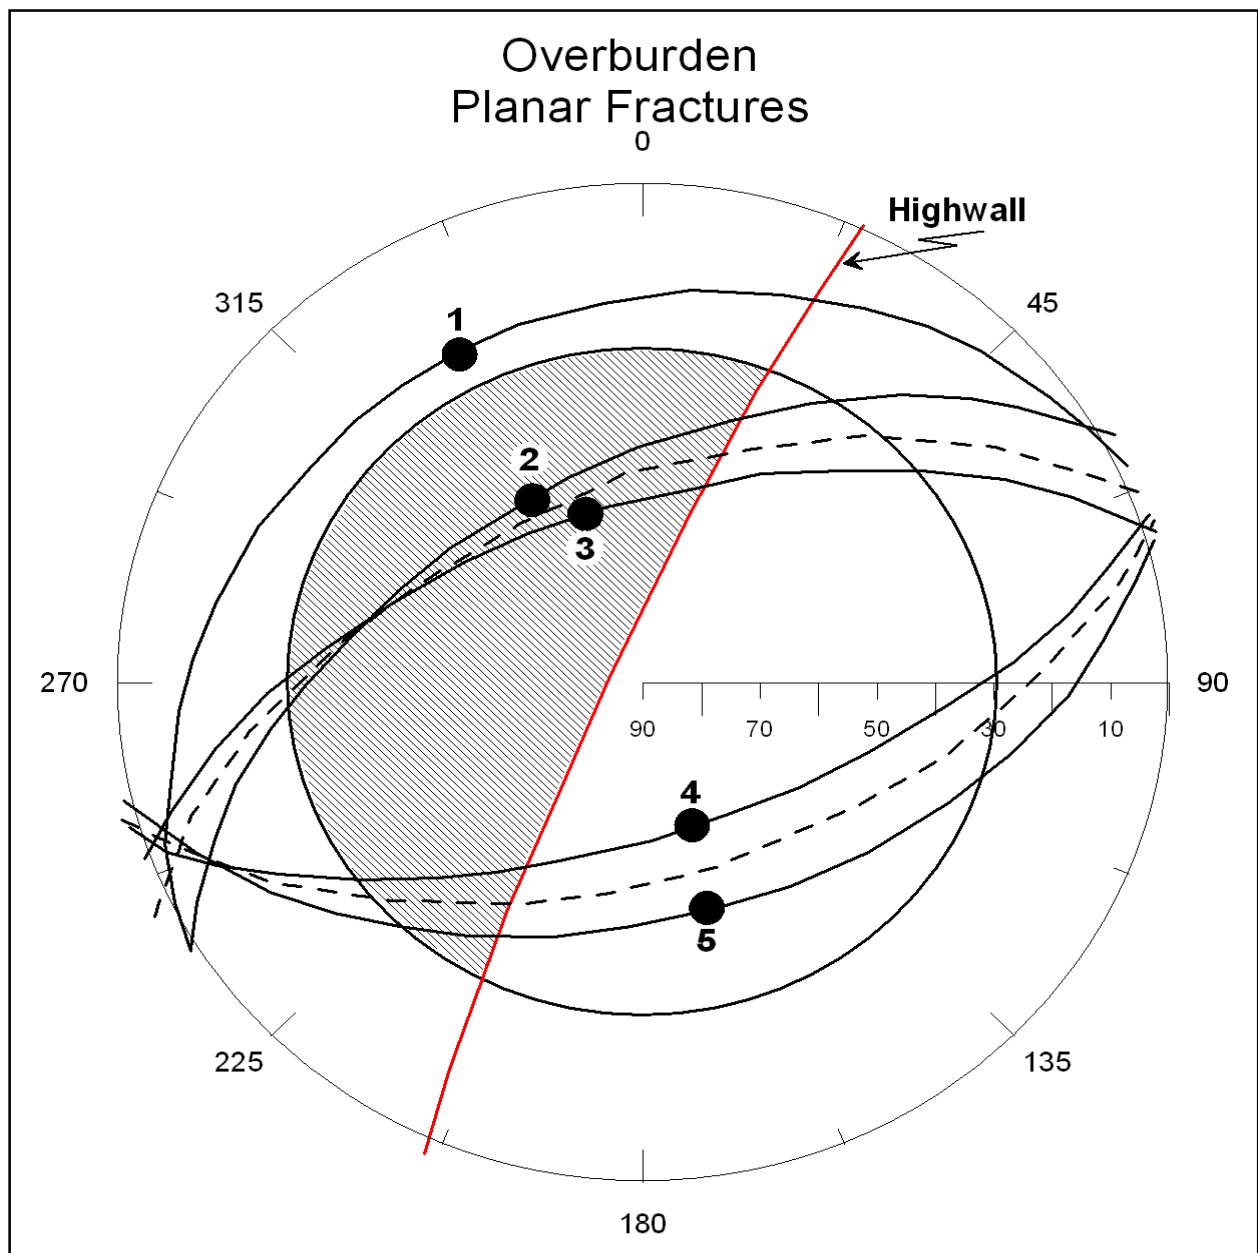
Figure 4.2.2.2 is the resultant stereoplot for the planar fractures identified in the overburden unit. Included on the plot is the 30° friction angle represented as a circle. A friction angle of 30° is commonly assumed for Karoo sediments, particularly the sandstones, siltstones and shales. The highwall great circle is also plotted to assist with interpretation.

**Figure 4.2.2.2:** Stereoplot of Planar Fractures in Overburden (digitized from hand-drawn stereoplot)

The shaded area in the stereoplot is the 'daylight' window; i.e. planes or wedges occurring in this area are considered unstable unless other factors promote stability. This is explained in the following interpretation of the stereoplot in Figure 4.2.2.2.

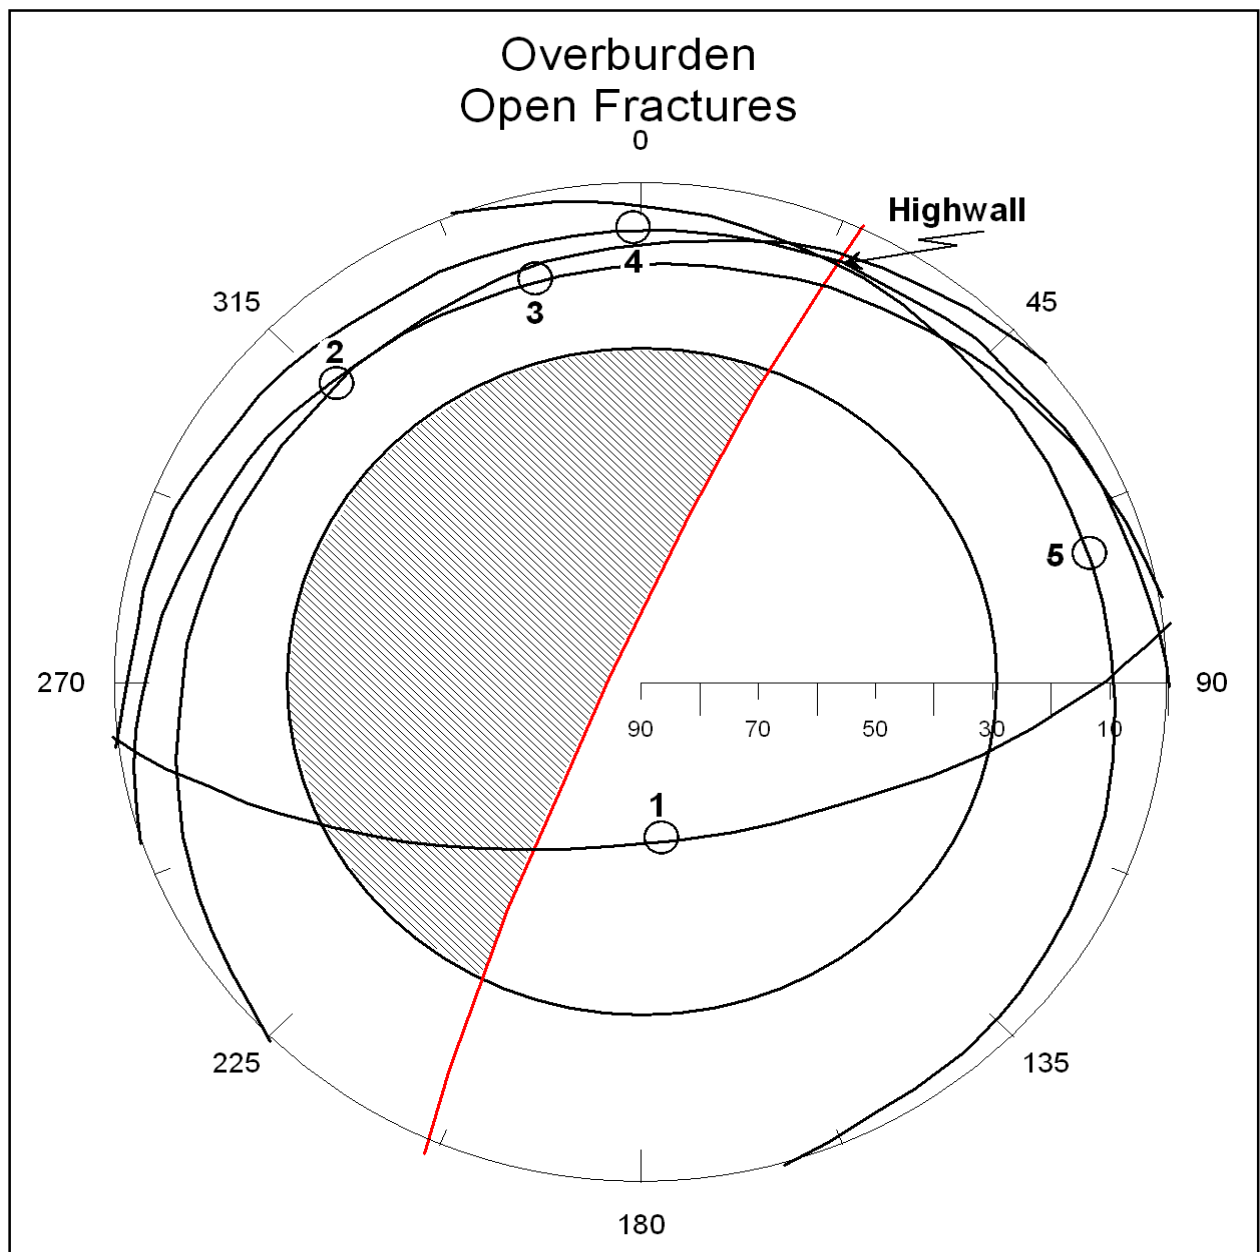
**Figure 4.2.2.3:** Stereoplot of open fractures in overburden (digitized from hand-drawn stereoplot)

#### Interpretation of overburden open fracture stereoplot (Figure 4.2.2.3):

- Open fracture 1 (OF<sub>1</sub>) dips steeply (62°) into the highwall and no movement is expected on this discontinuity.
- OF<sub>2</sub>, OF<sub>3</sub> and OF<sub>4</sub> all dip gently (< 30°) out of the highwall and therefore no planar failures are to be expected.
- OF<sub>5</sub> dips gently (< 30°) into the highwall and thus no movement on this discontinuity is expected.

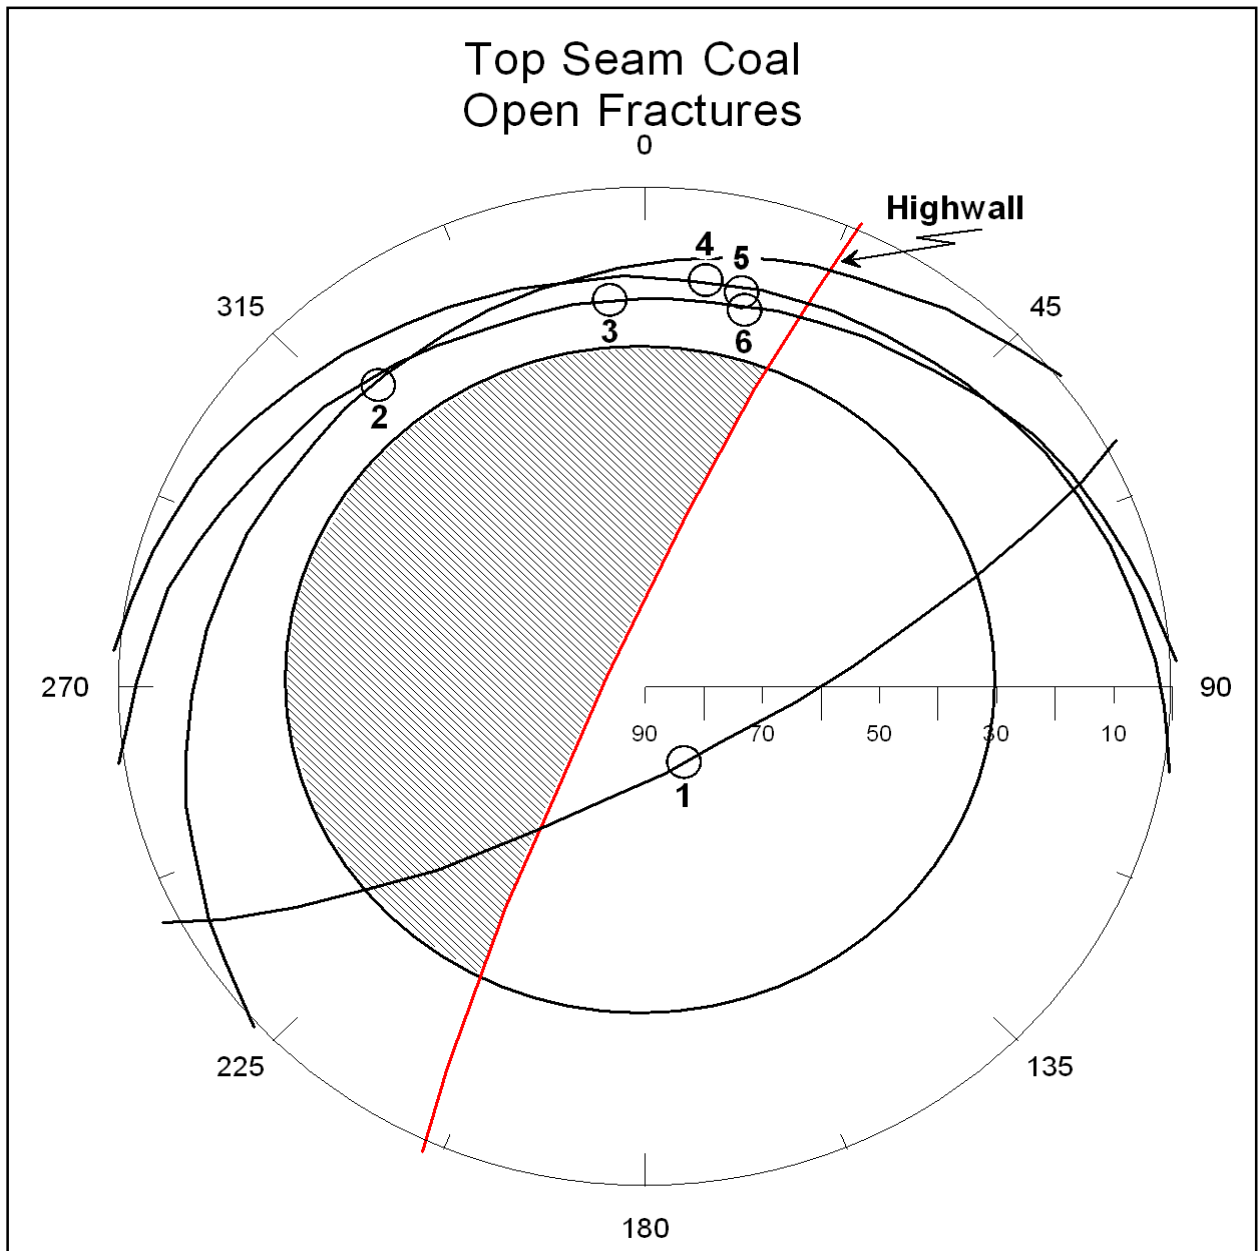
**Figure 4.2.2.4:** Stereoplot of open fractures in top seam coal (digitized from hand-drawn stereoplot)

#### Interpretation of top seam coal open fracture stereoplot (Figure 4.2.2.4):

- Open fracture 1 (OF<sub>1</sub>) dips steeply (75°) into the highwall and therefore no potential for planar failure exists.
- All remaining fractures dip out of the highwall but at less than 30° and, therefore, no failures are expected on these discontinuities.
- The wedge formed by the intersection of OF<sub>1</sub> and OF<sub>2</sub> dips very gently to the south-west and no wedge failure is expected.

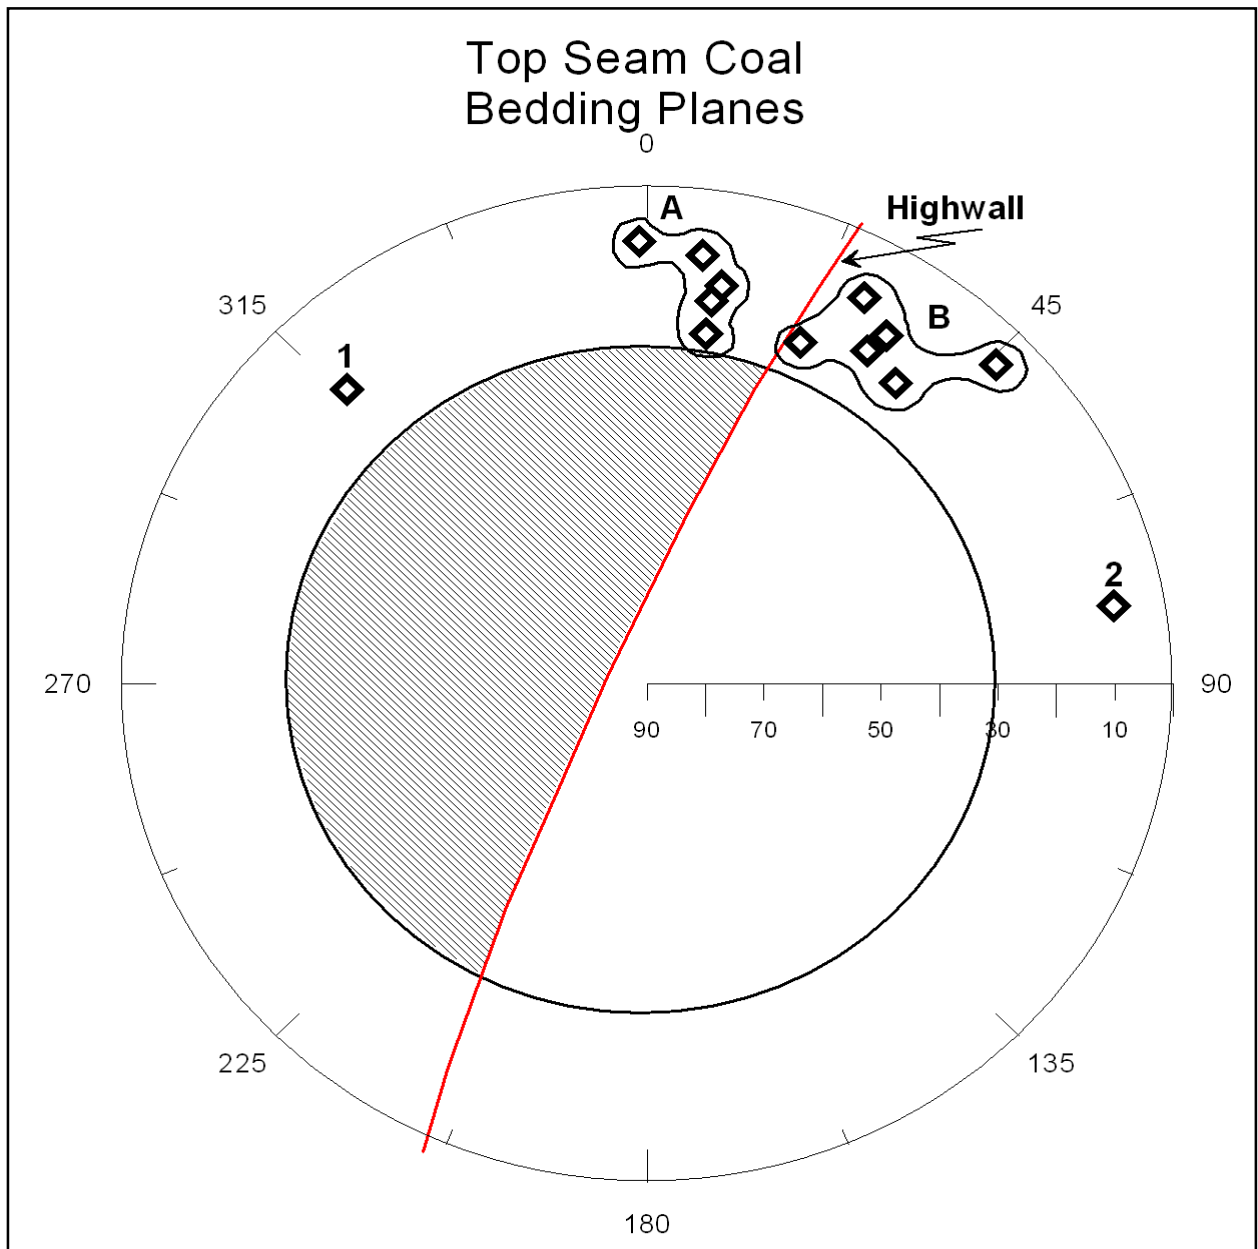
**Figure 4.2.2.5:** Stereoplot of bedding planes in top seam coal (digitized from hand-drawn stereoplot)

NOTE: no great circles are plotted. This large data set will result in a busy stereoplot and the interpreter needs to visualise the great circles.

- Bedding Planes 1 and 2 are outliers to the majority of the data. They have potentially been misinterpreted as bedding planes. Since they are all very gently dipping there is little cause for concern.
- The two concentrated groups (A and B) indicate that the bedding dips gently north to north-east *i.e.* the strata strike is almost perpendicular to the highwall and is relatively flat lying.

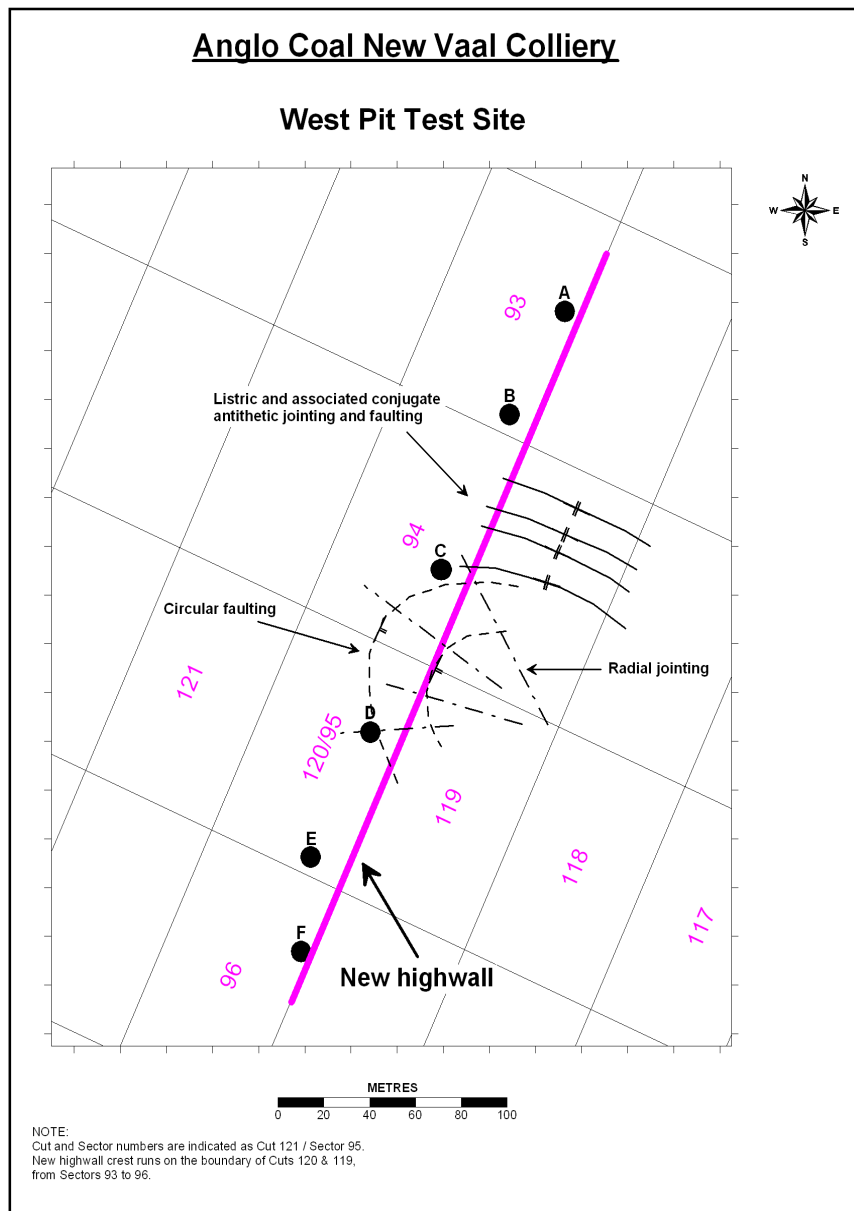
**Figure 4.3.1.1:** Potential discontinuity pattern (faults and joints) in overburden and top seam coal units inferred from contour data

- Although the regional jointing pattern has been described (Section 3.1 and Figure 3.1.5), cognisance must be given to potential localised discontinuities. These are illustrated in Figure 4.3.1.1.

- Strata dip direction favours highwall stability (it dips either parallel to or into the highwall).
- There is potential for planar failure on the NE-SW trending regional joint set, if it is persistent in this area. This is due to the additional loading in the Sector 94 area, and the potential for release planes to be formed by the NW-SE jointing that may be present.
- Potential wedges formed by the intersection of both regional joint sets, if persistent in this area, may also be affected by the additional loading in the Sector 94 area.

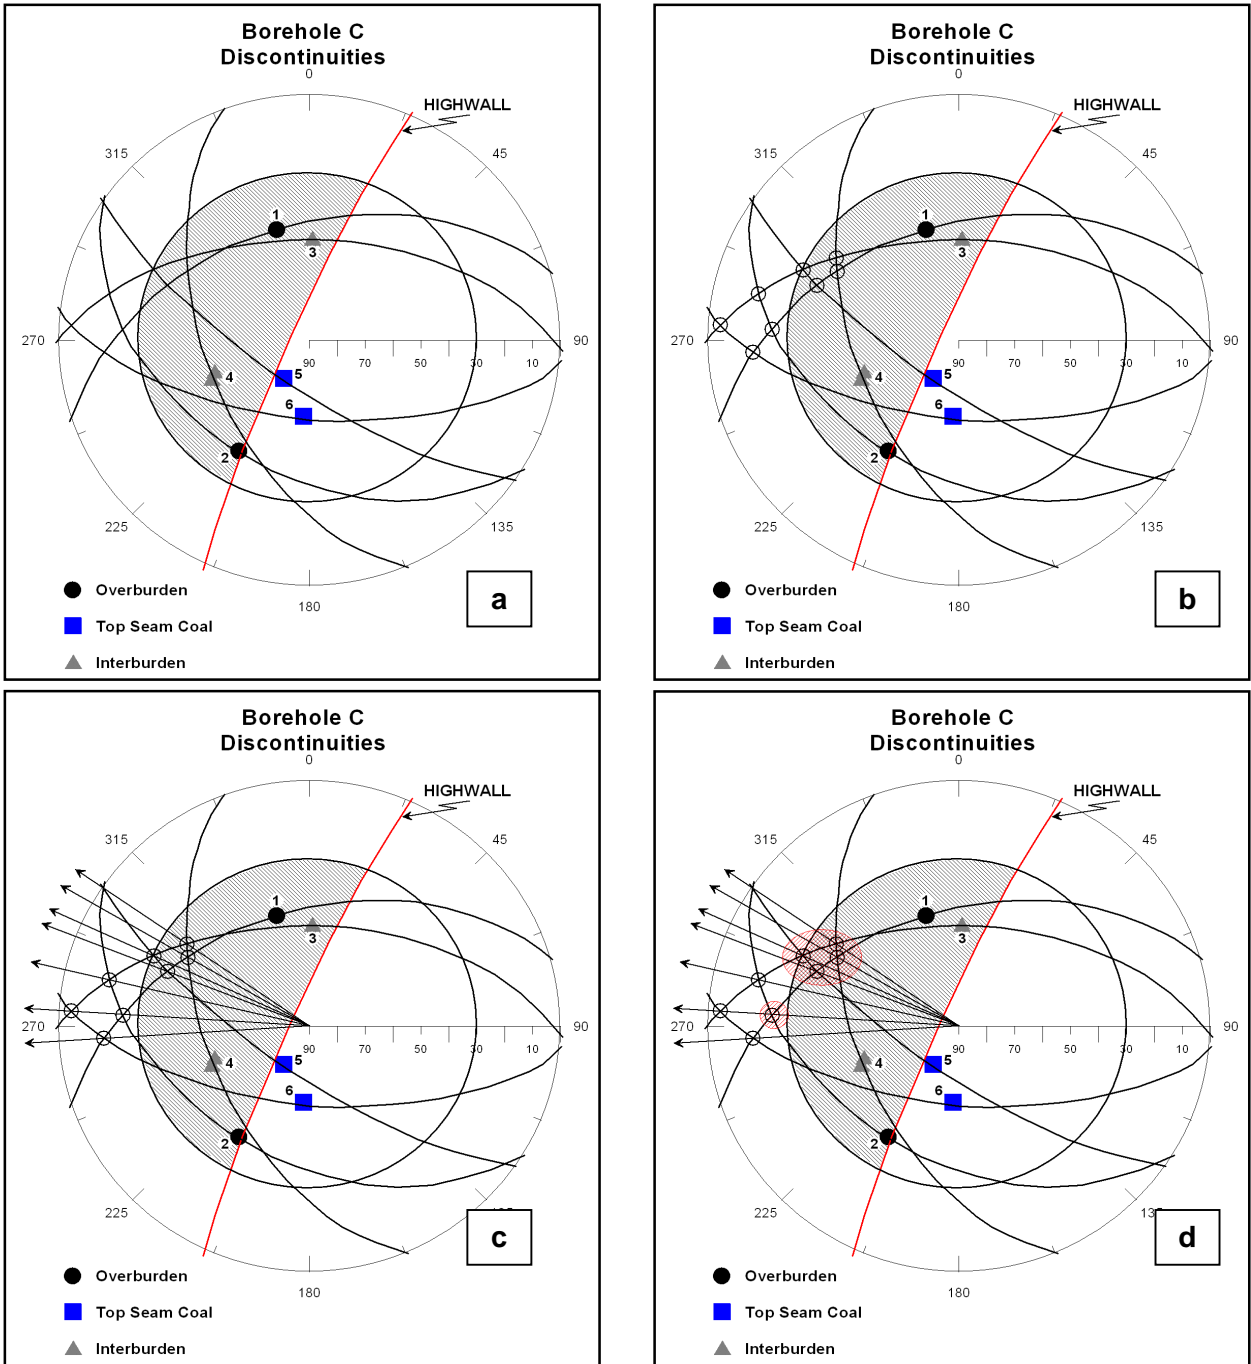
**Figure 4.3.1.5:** a) Great circles for discontinuities D1 to D6; b) Intersections (circled) between conjugate pairs forming wedges; c) Lines drawn through intersections indicating direction of potential sliding; d) Danger zones (red hatched) where a conjugate pair's line of intersection is greater than 30°

Figure 4.3.1.5 indicates that the discontinuity pairs that form potentially unstable wedges are: D1/D2; D1/D4; D1/D5; D3/D4; and D3/D5. With the exception of the D1/D2 wedge, all the others fall within the 30° friction angle circle, indicating that their individual lines of intersection are greater than 30° and, therefore, sliding is possible. The D1/D2 wedge is included, since its line of intersection is only a few degrees less than the critical angle and movement (sliding) may be induced by other factors such as additional highwall loading. In this instance, additional loading can be induced by the elevated surface topography to the SE of Borehole C (Figure 4.2.1.3). Such features need to be taken into account when the stability of highwall slopes is assessed.

The hazard matrix, for the wedges identified in Borehole C as potentially unstable (Figure 4.3.1.6), indicates that the highwall in that region (refer to borehole position in Figure 4.3.1.1) has a high probability for instability. However, further fieldwork is necessary to confirm this assessment. It has previously been mentioned that no information regarding discontinuity persistence (along dip and strike) is gathered from geophysical wireline televiwer data and, thus, in-pit highwall and surface mapping will have to be carried out on a continuous basis as the current highwall advances to the new position. Only through detailed mapping will valuable data, such as discontinuity persistence and the presence or development of surface tension cracks, be obtained. It is possible, however, to flag this area of the pit (Cut 119, Sector 93) as a potentially hazardous area, requiring follow-up work as mining advances into this area.

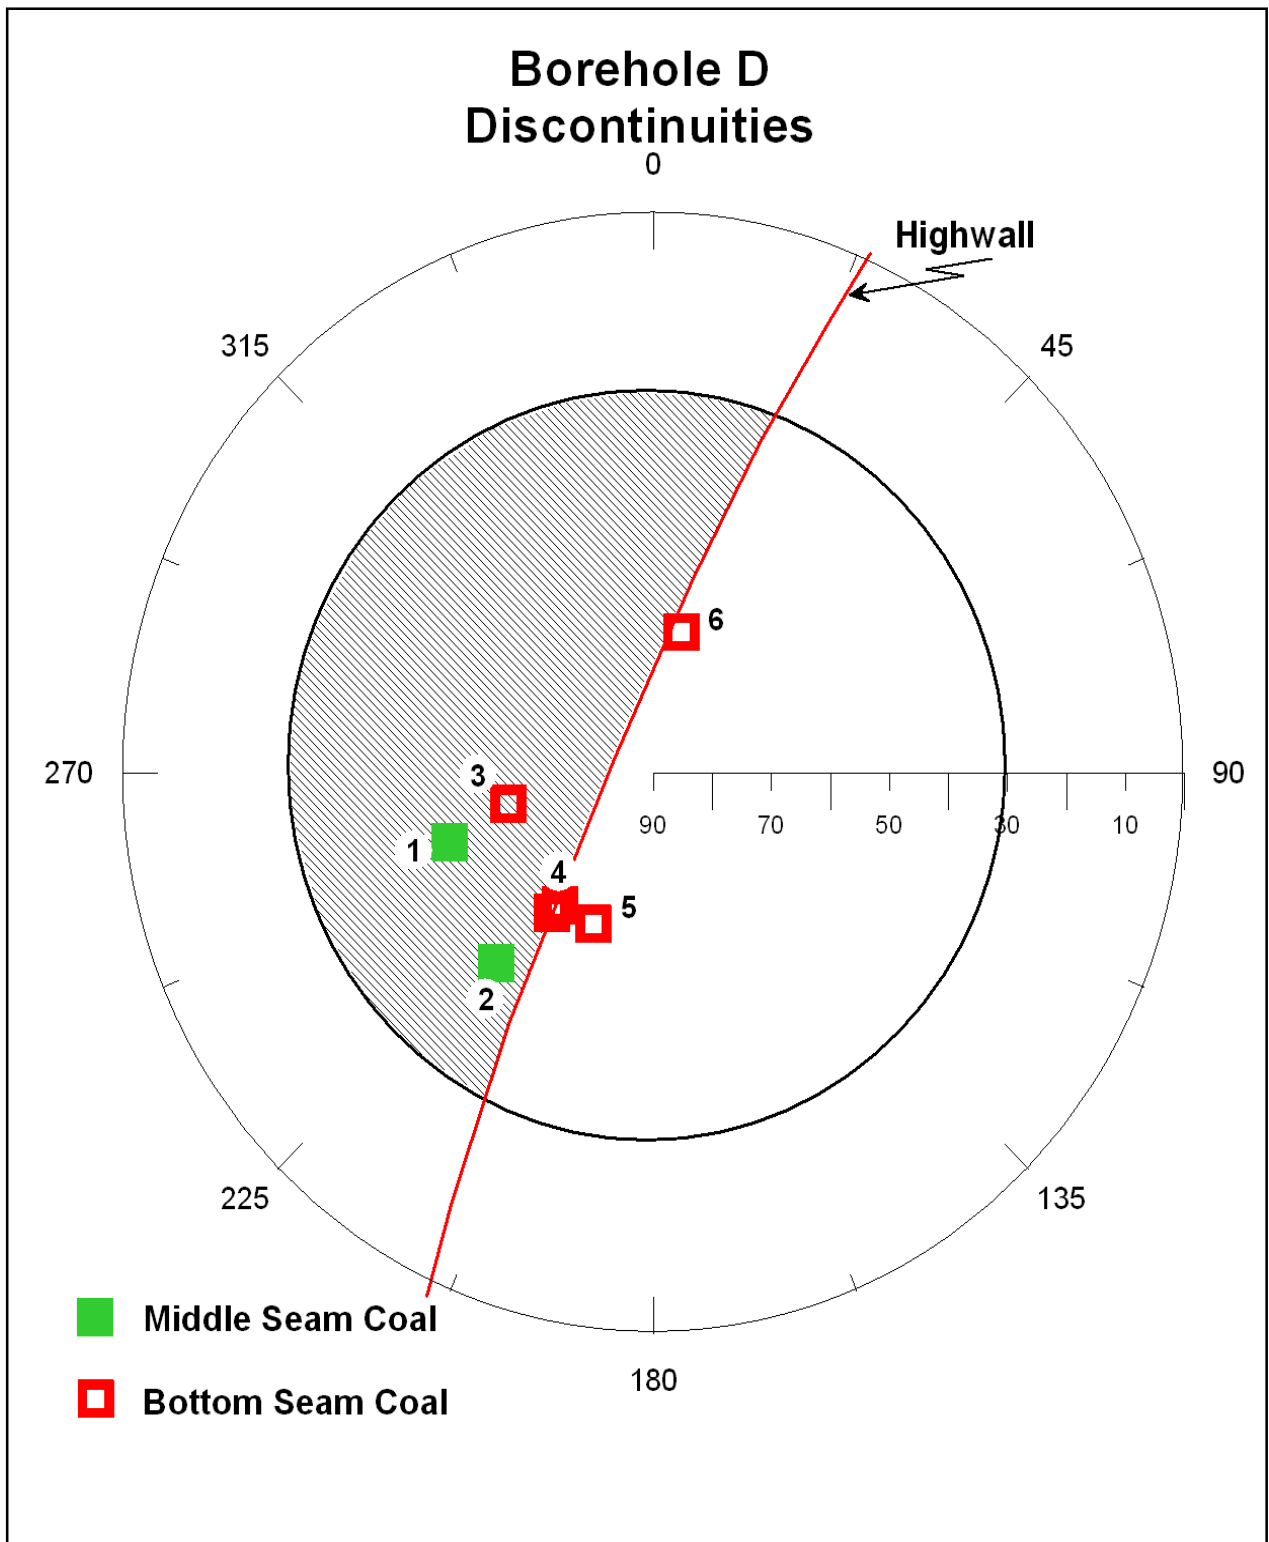
**Figure 4.3.2.1:** Stereoplot of discontinuities identified in Borehole D for Middle and Bottom Seam Coal units

Figure 4.3.2.1 is a stereoplot of discontinuities identified in Borehole D. The majority of the discontinuities dip in a general SW direction, with one exception dipping to the NE. The discontinuities dipping to the SW, although relatively steep, strike at too high an angle to the highwall to result in plane failure. However, there is a potential for unstable wedges to be formed between the SW-dipping discontinuities and the NE-dipping discontinuity. A wedge analysis is performed, similar to that for Borehole C, and the series of stereoplots is presented in Figure 4.3.2.2.

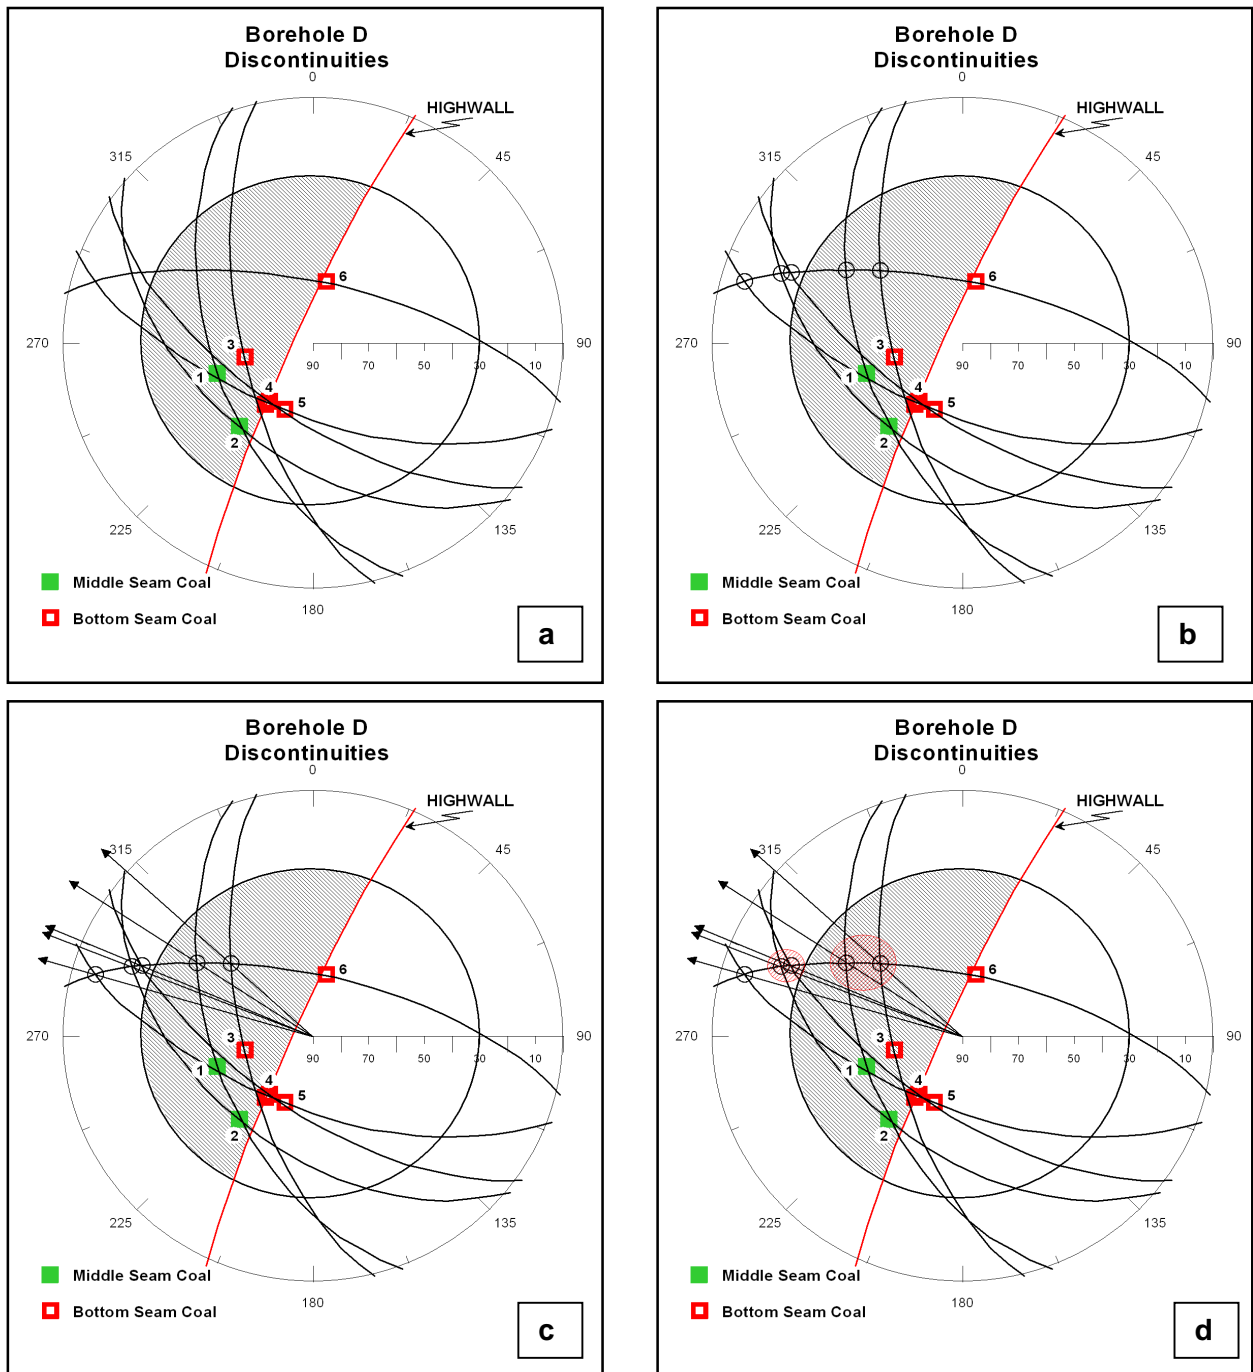
As can be seen from this series of stereoplots, discontinuity D6 forms wedges with all the other discontinuities, and all the lines of intersection dip close to perpendicular out of the highwall. However, only the pairs D1/D6 and D3/D6 dip more steeply than 30° (Figure 4.3.2.2.d). The pairs D2/D6 and D4/D6 have been highlighted as being potentially unstable because even though their lines of intersection dip less than 30°, additional highwall loading (Figure 4.2.1.3) may influence the stability of these wedges. The line of intersection for the D5/D6 pair dips at approximately 10° and is thus considered to be stable. All the discontinuity pairs are entered into the hazard matrix (Figure 4.3.2.3) to establish the overall hazard rating for the section of the highwall in the vicinity of Borehole D.

As can be seen from the hazard matrix, the overall rating is “moderate to high”. Although the strata dip close to 10° into the highwall, and therefore have a stabilising effect on the highwall, the two wedges dipping steeply out of the highwall are cause for concern. This area will require more detailed highwall and surface mapping as mining progresses into the area. Borehole E has been drilled in the same sector (119/95) as Borehole D and the discontinuity data for Borehole E will be analysed in the same fashion as for the previous boreholes. Since two holes are used for this sector, the results from the two hazard matrices can either be averaged or used independently.

**Figure 4.3.2.2:** a) Great circles for discontinuities D1 to D6; b) Intersections (circled) between conjugate pairs forming wedges; c) Lines drawn through intersections indicating direction of potential sliding; d) Danger zones (red hatched) where a conjugate pair's line of intersection is greater than  $30^\circ$
