**COALTECH 2020**

## **Task 1.4**

# **Geotechnical factors affecting high- and low-wall stability in opencast coal mines**

**May 2004**

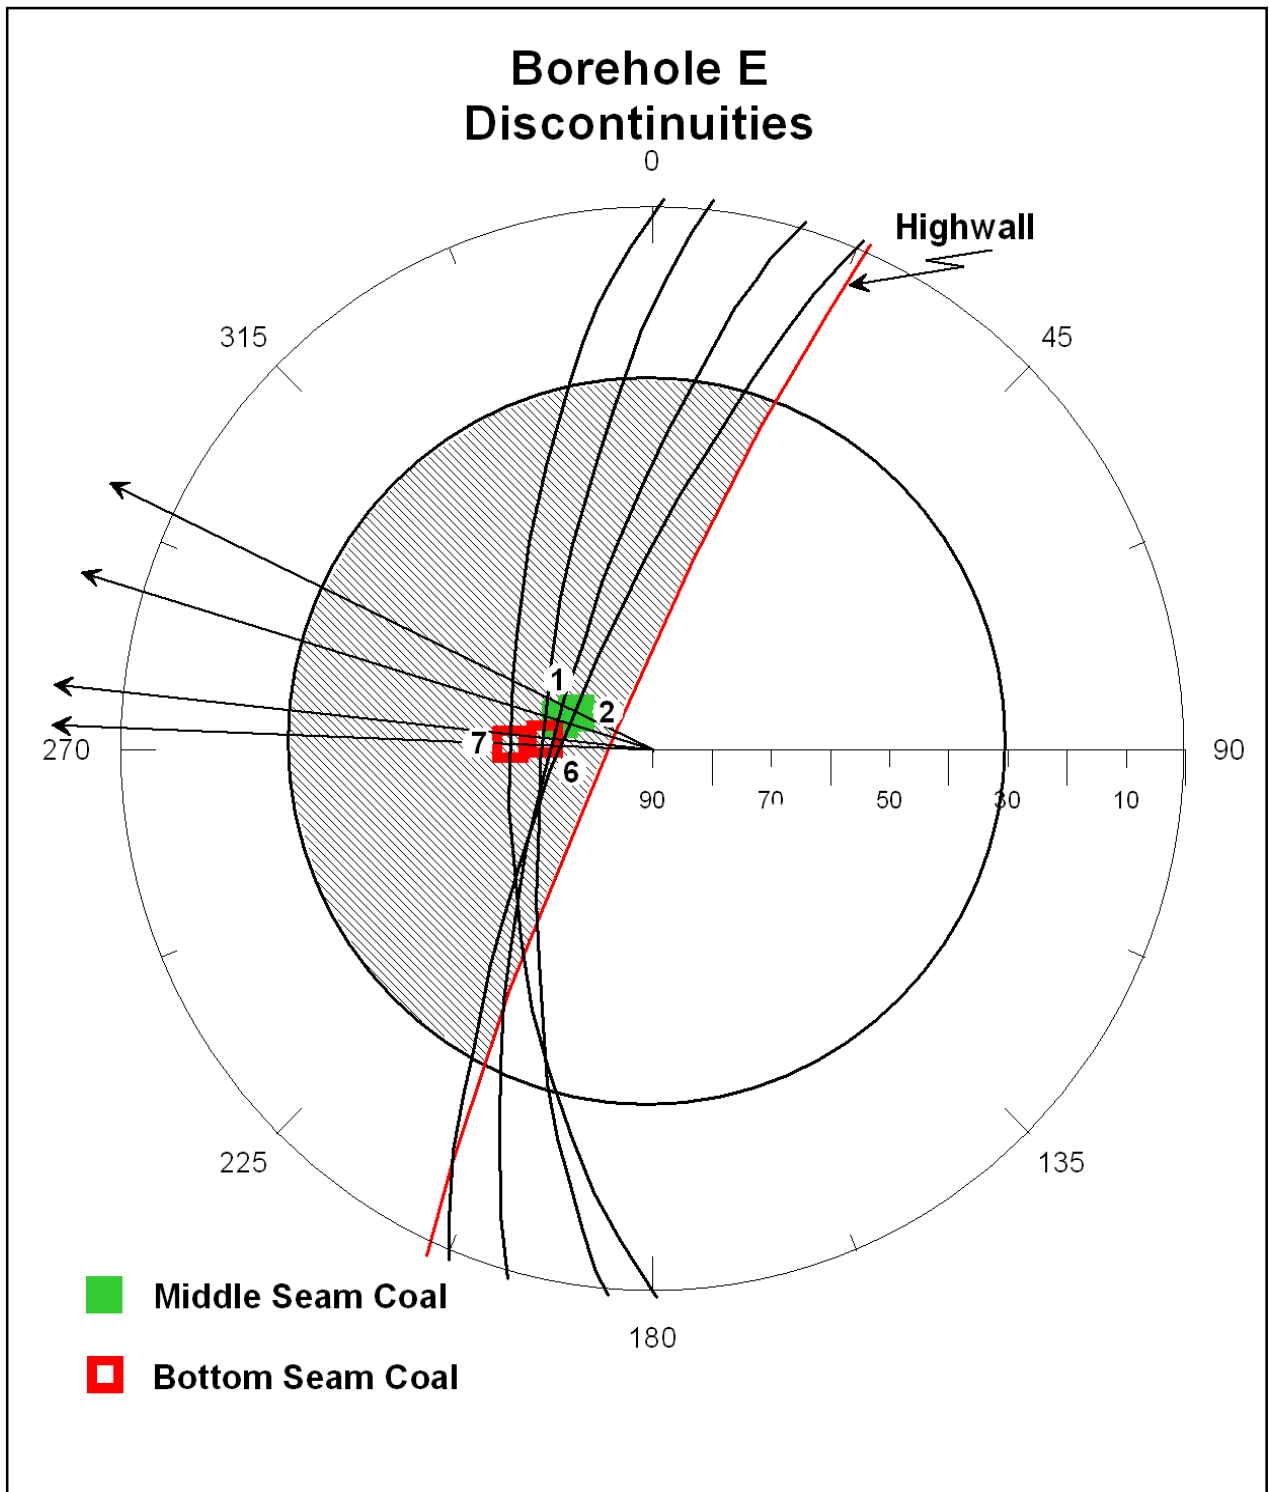
**Figure 4.3.2.5:** Great circles for discontinuities that may result in plane failure. Also indicated are the individual directions of potential sliding for each discontinuity

The hazard matrix for plane failures is presented in Figure 4.3.2.7 and the hazard matrix for the wedge failures is presented in Figure 4.3.2.8. These are presented separately so as not to clutter the matrix, and the final hazard rating for Borehole E takes into account both hazard matrices. As indicated by the plane failure hazard matrix (Figure 4.3.2.7), plane failure in the vicinity of Borehole E is very likely. Considering the geometries necessary for plane failure to occur (Section 2.3), it is necessary to follow up with detailed surface and highwall mapping as mining approaches this area.

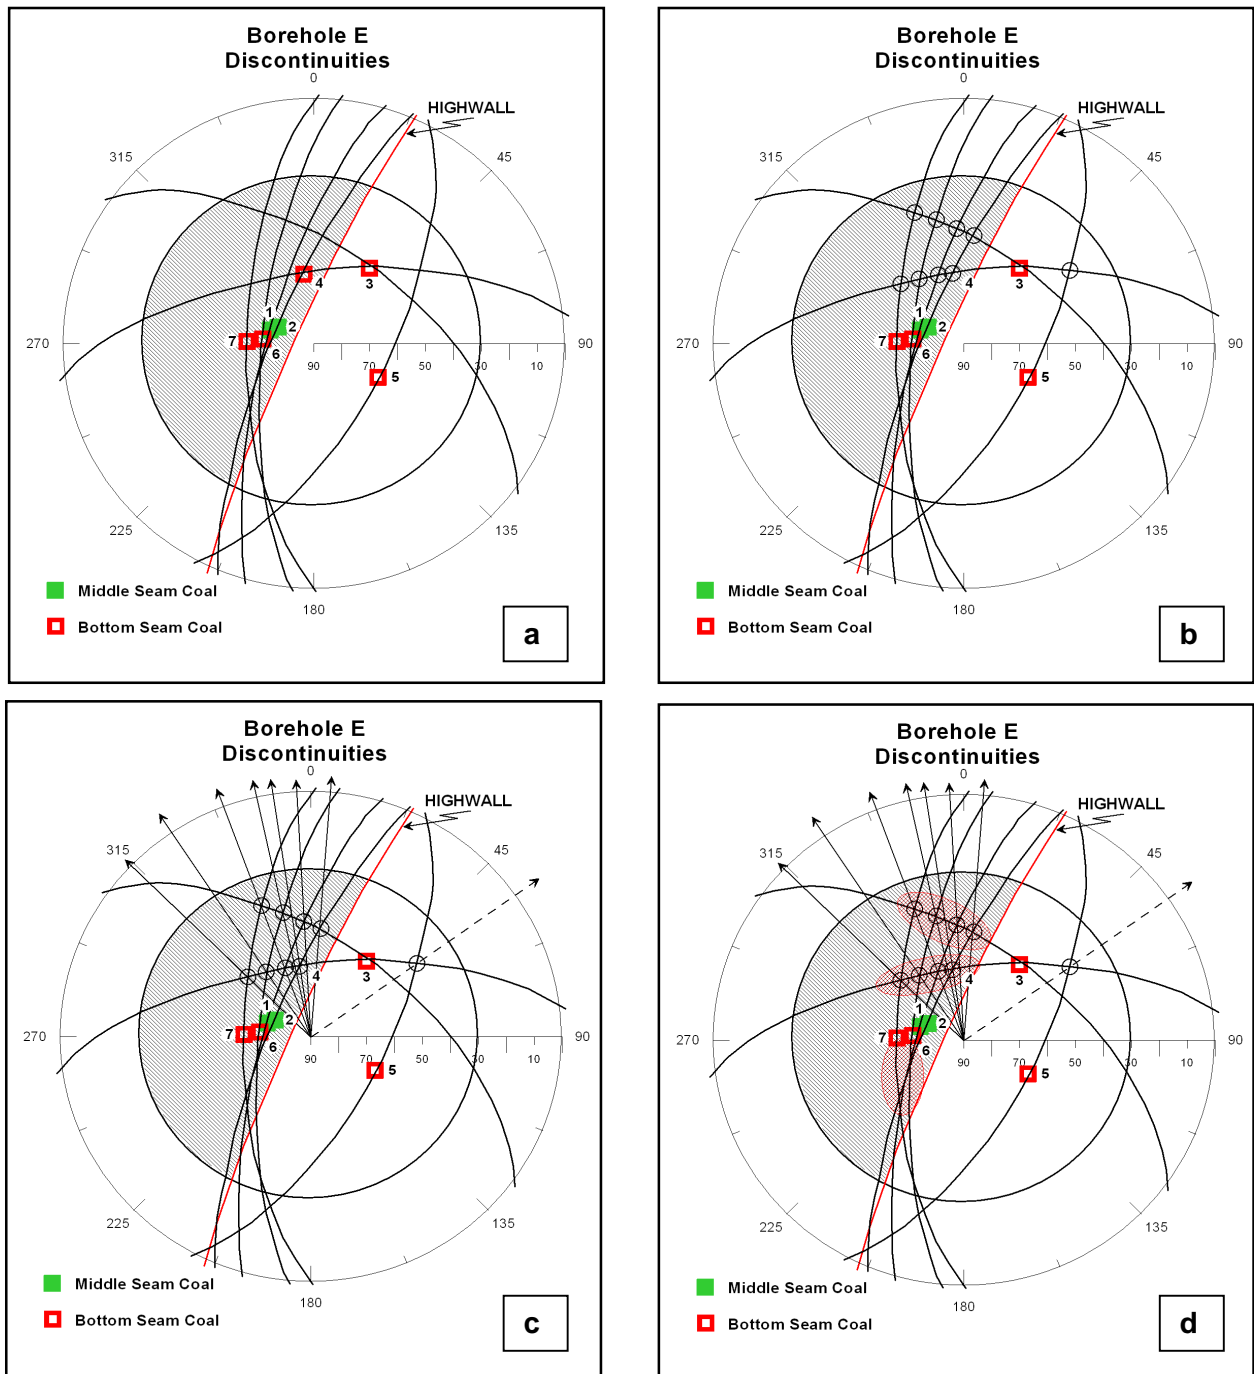
Before the information regarding the potential plane failures is entered into the hazard matrix, the potential for unstable wedges to form must be assessed. The wedge failure analysis is again performed by way of the series of stereoplots, as shown in Figure 4.3.2.6. As can be seen, up to eight potentially unstable wedges can be formed. All are dipping out of the highwall and all the lines of intersection are steeper than  $30^\circ$ . The only exception is the wedge formed by the discontinuity pair D3/D5, which is dipping into the highwall and is therefore stable. Although the intersections between the discontinuities D1, D2, D6 and D7 do not form wedges, the area is highlighted as being hazardous, since the numerous intersecting discontinuities may have a destabilising effect on the rock mass.

**Figure 4.3.2.6:** a) Great circles for discontinuities D1 to D7; b) Intersections (circled) between conjugate pairs forming wedges; c) Lines drawn through intersections indicating direction of potential sliding; d) Danger zones (red hatched) where a conjugate pair's line of intersection is greater than 30°

The potential for wedge failure is also high as indicated in the wedge failure hazard matrix (Figure 4.3.2.8). The wedge formed by the discontinuity pair D3/D5 is omitted from the hazard matrix since it is clear that this wedge does not pose any stability problems as it dips into the highwall. All the other wedges are considered to pose stability problems, and it is thus necessary to follow up with detailed in-pit mapping as mining enters this area.
